## Lost time injury (LTI): Incident with circular saw leads to loss of thumb

Safety Flash Published on 10 July 2012 Generated on 22 January 2025 IMCA SF 07/12

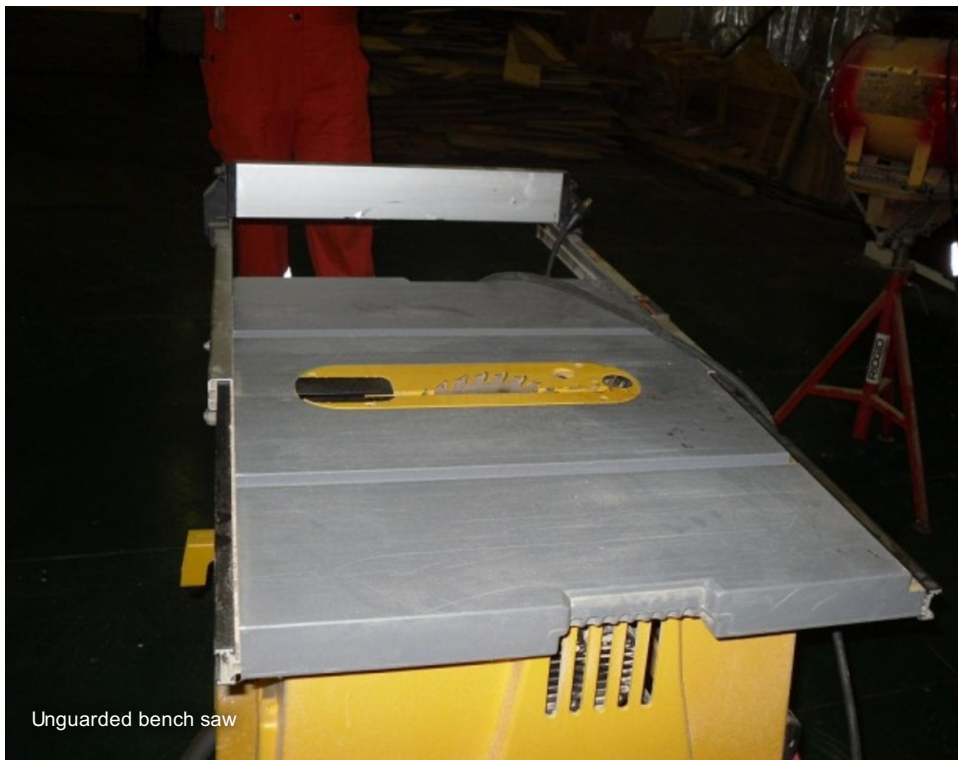
The incident occurred when the crewman was cutting 5mm thick plywood with the circular saw in order to make shelving for other plywood pieces. The plywood was laid flat on the bench with the injured person's hands laid flat on top of the plywood, but the plywood snagged and dragged the crewman's right hand towards the spinning blade. The injured person was medivaced ashore by helicopter in a timely manner after immediate first aid onboard had been administered. The surgeons at the local hospital managed to reattach the middle finger but the top of the thumb was lost.

- No risk assessment had been conducted for the operation.
- The equipment was incorrectly set up and incorrectly operated by the injured person, though he stated that he was familiar with the operation of the equipment.
- The bench saw was supplied on board with the necessary safety equipment and full instructions for its safe operation. These instructions included reference to the use of the safety guard, a special tool for pushing the wood through, and the requirement to set the cutting blade to the correct level in accordance with the thickness of the wood that was being cut.
- The instruction manual appeared not to have been available at the workplace and the safety requirements for the safe operation of the saw were either not fully understood or were disregarded.
- There was no guard fitted to the circular saw blade.

- All power tools have the potential to cause serious injury if they are operated incorrectly and without the manufacturers' approved and fitted safety devices.

- A risk assessment must be completed and filed prior to using any power tool. The assessment must take into consideration the following:
  - the competence of the persons using the equipment

- the condition of the equipment being used
  - the provision and proper functioning of adequate safety guards and cut-out devices such as emergency stops and barriers

- general working environmental conditions such as lighting
  - availability and condition of any personal protective equipment
- Guards must always be fitted to equipment when designed to have them in place during operations.

- Power equipment should be operated in accordance with the procedures and rules set for their safe use.
- Full training, manuals and instructions should be available, and manuals and instructions should always be read and fully understood by even experienced operators.
