UK HSE: worker falls from height during oil platform decommissioning

Safety Flash Published on 1 April 2022 Generated on 28 January 2026 IMCA SF 08/22

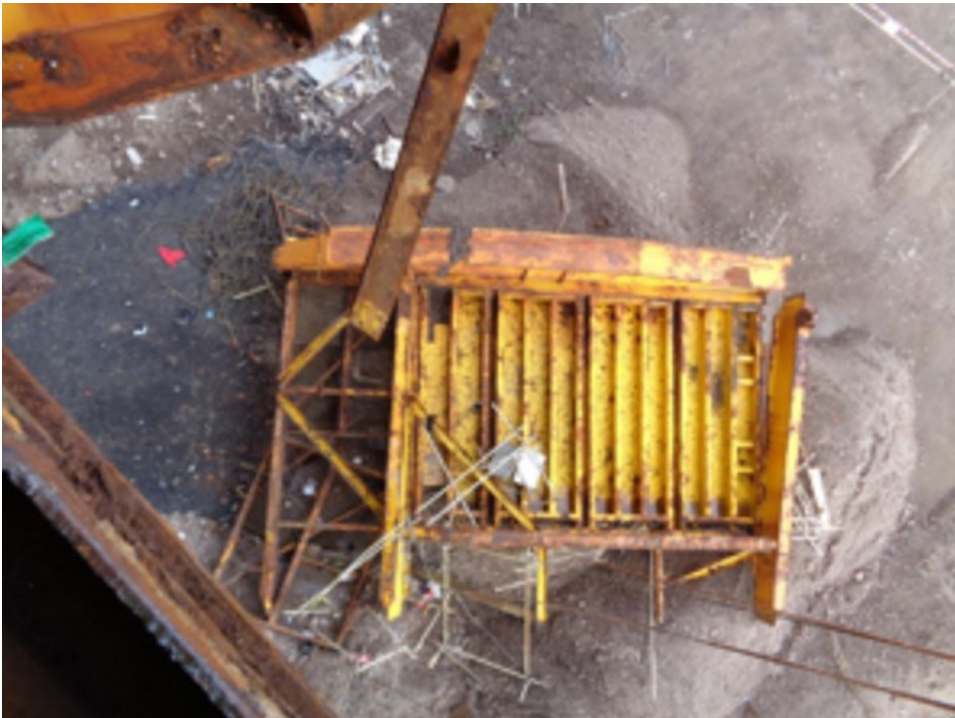
It was **not recognised by the planning team** that one of the platforms did not form part of the main structure and was attached to the platform using bolts that had corroded over time. This affected the structural integrity of the platform and the methodology required to remove it safely. During the cutting of bracing beams, the platform unexpectedly collapsed causing one of the employees to fall 15 metres.

An investigation by the Health and Safety Executive (HSE) into the incident found that the company had failed to carry out a full structural appraisal of the platform

prior to demolition. This would have informed the risk assessment and method statement being used by the cutting crew at the time of the incident to ensure that the work could have been carried out safely.
