Case study: Lone watchkeeping grounding at night

Safety Flash Published on 30 March 2021 Generated on 28 January 2026 IMCA SF 09/21

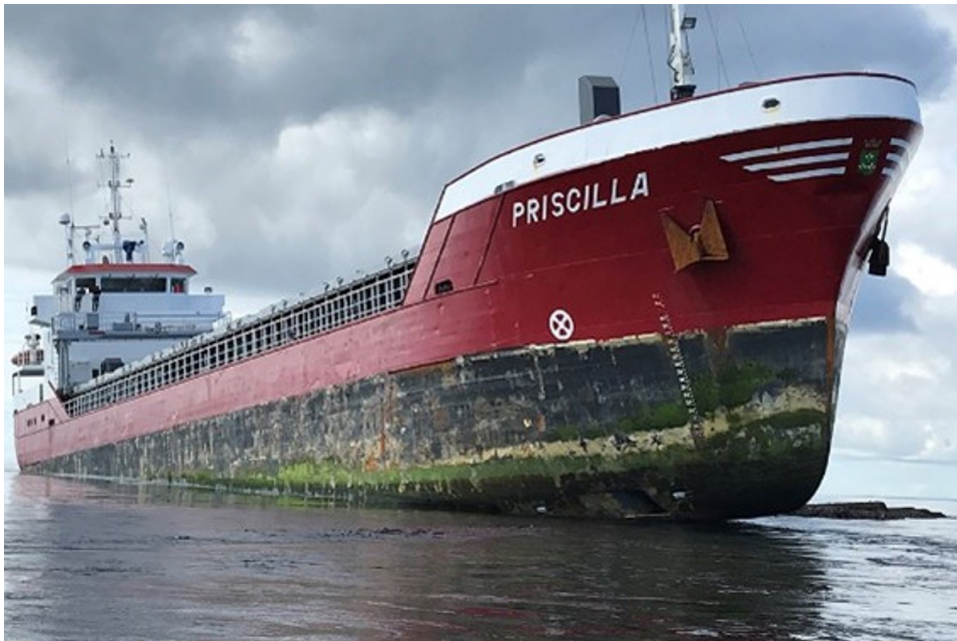
The ship ran aground because it drifted to the south of the planned track while on autopilot.

The Officer of the Watch did not monitor the ship's progress for about two hours while sitting in the bridge chair watching videos on his mobile phone.

- **Pay attention to what is happening around you!!**
- Monitoring vessel progress along the planned passage is a vital component of safe navigation, and the officer of the watch should not become distracted from this responsibility.
- Reducing to a sole lookout should be properly risk assessed.
- Electronic navigation aids should always be set up to aid the officer of the watch by giving warning of danger ahead.
