Unsecured cargo inside containers

Safety Flash Published on 12 May 2017 Generated on 24 January 2025 IMCA SF 10/17

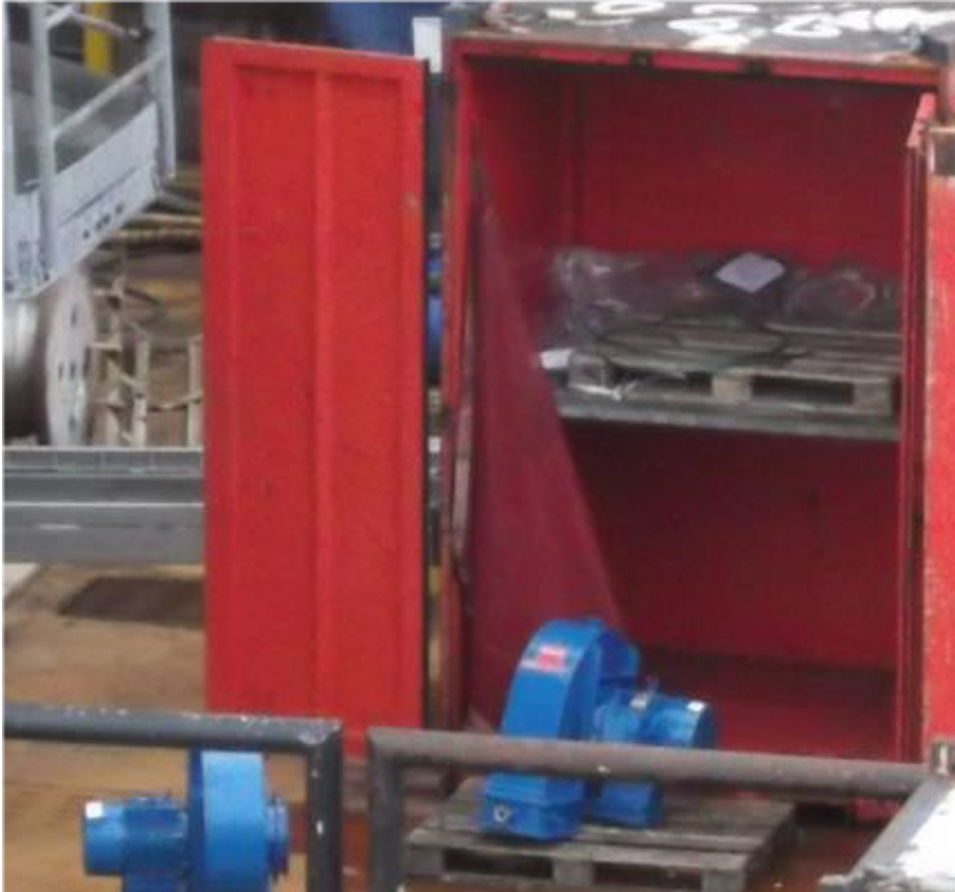
Step Change UK reports an incident in which an unsecured motor in a cargo carrying unit (CCU) fell to deck as it was being secured. No-one was harmed but the motor, which weighed 95 kg, was extensively damaged.

When opened, a CCU was found to be a shelved unit containing two palletised blower motors each weighing 95 kg – one on the lower level and the other on the shelf. It was intended to remove only the lower motor and send the second (upper) motor back onshore for reloading. The upper motor was not secure and moves were made to secure it before back loading. As crew climbed onto the shelf in attempts to secure the motor, its pallet shifted and tipped forward. The motor fell from height onto the deck, causing extensive damage to the motor. No one was injured during the incident, but had there been crew in the way, this could have resulted in serious personal injury.

Action

Members may wish to refer to the following incidents (search words: *cargo, unsecured*):

- Loading and securing of containers
- Loading and securing of cargo
