Dropped load and failed chain

Safety Flash Published on 17 March 2020 Generated on 12 January 2025 IMCA SF 10/20

A chain link failed, causing a load of over 260 kg to fall 1.5 m to deck.

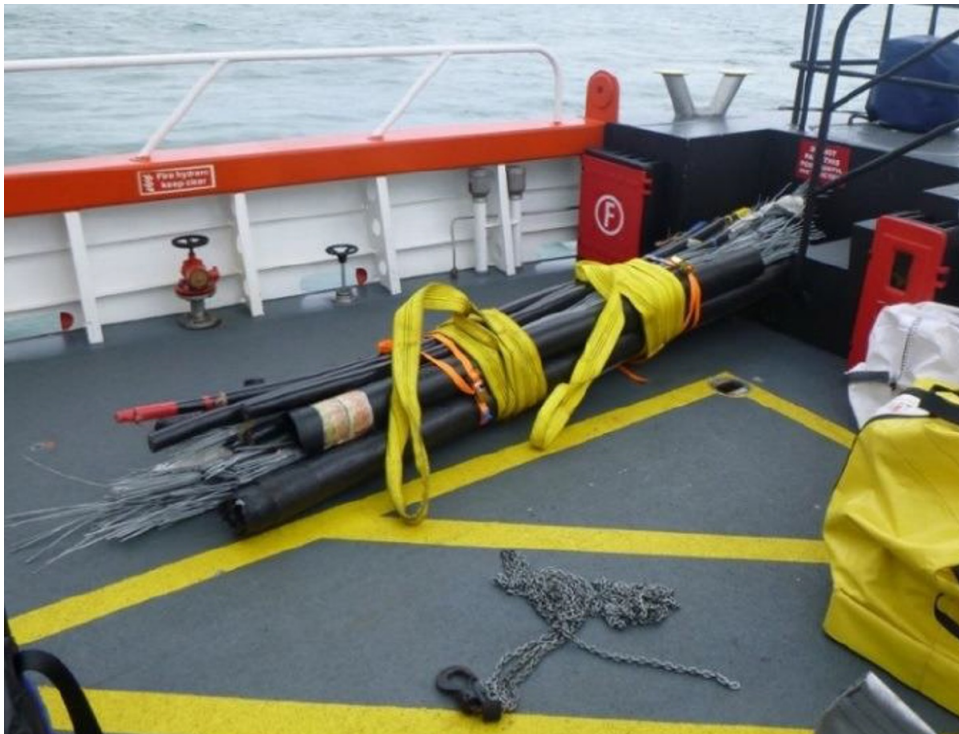
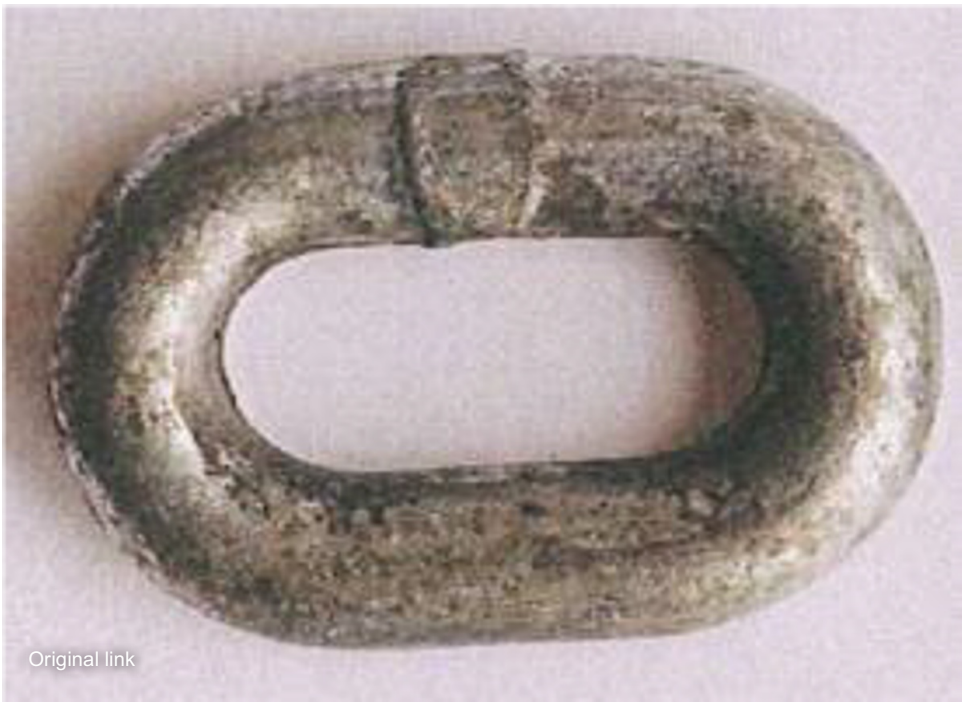
The incident occurred during transfer of a bundle of scrap cable, when a chain link snapped causing the load to fall the last 1.5 m to deck.

The load weight was estimated to be between 260 and 390 kg. The failed chain link was approximately 10.5 m from the hook.

- The most recent inspection of the chain hoist was 3 months prior this incident.
- At the time of the occurrence, the chain link that failed was in the vertical plane and mid-air – the failure was unexpected and not caused by any torque, friction, tension or bending.
- The chain was at approximately 12% of its theoretical lifetime. Post-incident break load testing showed an actual break load of the chain of 3400 kg. Metallurgic and fracture investigation were conducted on the actual chain.
- The failed link showed to have had an external impact on the weld side, which caused weakening of the structure by approximately 90%. This caused a failure mechanism different from normal overload breaking.

- Regular visual inspections of your lifting gear.
- Be aware that any external impacts on lifting gear may have a negative impact on its strength.
- Any damage spotted on lifting equipment should be reported and when necessary, such equipment quarantined and re-inspected.

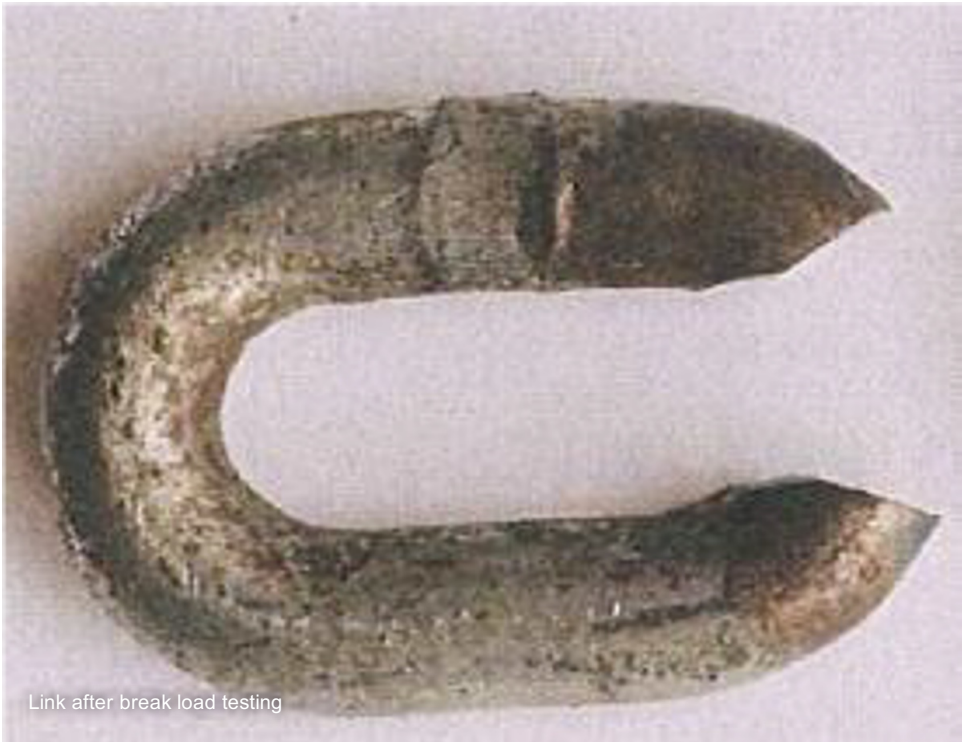
Original link
