BSEE: Person injured when safety mechanisms failed

Safety Flash Published on 20 April 2023 Generated on 22 January 2025 IMCA SF 10/23

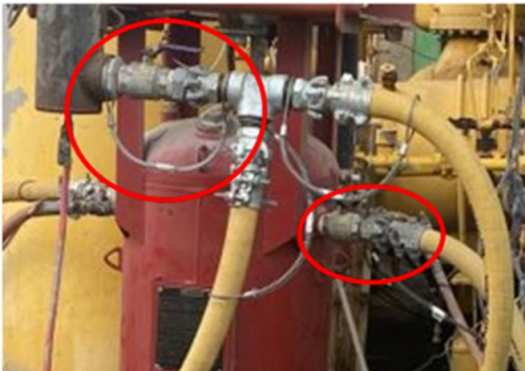
The worker was refilling the sand pot with an abrasive material to continue sandblasting operations. After confirming the air supply valve from the temporary air dryer to the sand pot was shut-in, the worker attempted to disconnect the air supply valve (Figure 1 – Right Circle) from the air dryer. As he tried to access this coupling, he loosened the T-connection. The T-connection blew off and broke the braided steel whip check or safety cable which hit the worker causing injury.

Figure 1 – Temporarily installed air dryer with bull hose connections. Original whip check position (Left Circle) and the location of the injured persons hand placement on the air supply valve (Right Circle).

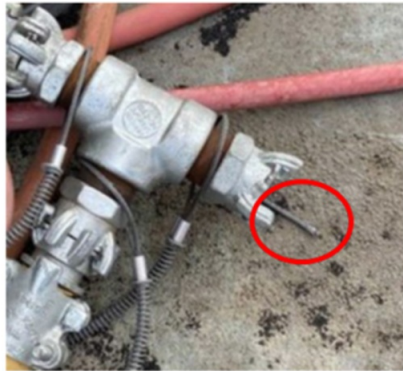
A broken whip check and T-connection hit the worker and caused multiple cuts and abrasions to his head and shoulders.

Figure 2 - Broken whip check from the incident.

- BSEE inspectors identified the following contributing factors:
 - The baling wire involved in the incident was slightly corroded, potentially diminishing its overall integrity. Baling wire is used as an additional safety measure to ensure couplings are securely connected. It is often used in place of a cotter pin on crowfoot couplings.
 - The failed whip check cable was improperly crimped. Crimping the whip check cable before placing it into service allows it to function correctly at its full rated capacity.

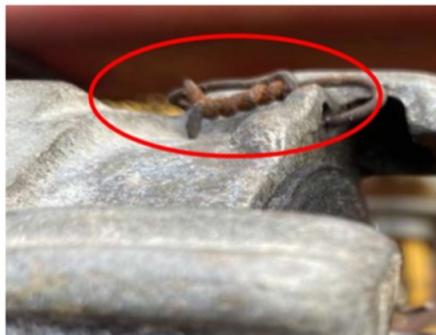
- The bull hose configuration on the air inlet valve from the platform air compressor was installed in a horizontal position. This added weight caused the T-connection to be off-centre at the time of operation, adding stress on the associated couplings and baling wire. The added weight, combined with the worker's force when manipulating the air supply valve to the sand pot, resulted in air escaping the inlet valve from the platform compressor, likely causing the connection to come loose.

Figure 3 – Baling wire on coupling that released.

- Ensure all risks and associated mitigations of this kind of task are fully understood.
- Install stainless steel tie wires in addition to whip checks on bull hoses to reduce the risk of disconnection.
- Install 90-degree fittings (see illustration) to eliminate the horizontal orientation of the supply hose, reducing the stress at each connection.
- Where practical, depressurise equipment prior to adjusting valves.
- Inspect all equipment and parts pre-job to ensure they are in adequate condition.

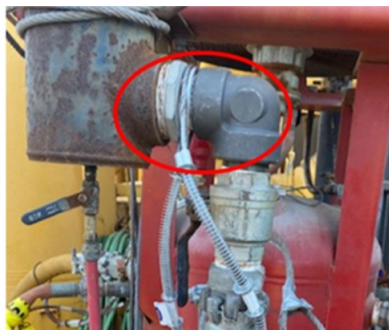
Figure 4 – 90-Degree fitting recommendation.
