Catastrophic failure of vessel main crane wire

Safety Flash Published on 23 June 2008 Generated on 28 January 2026 IMCA SF 11/08

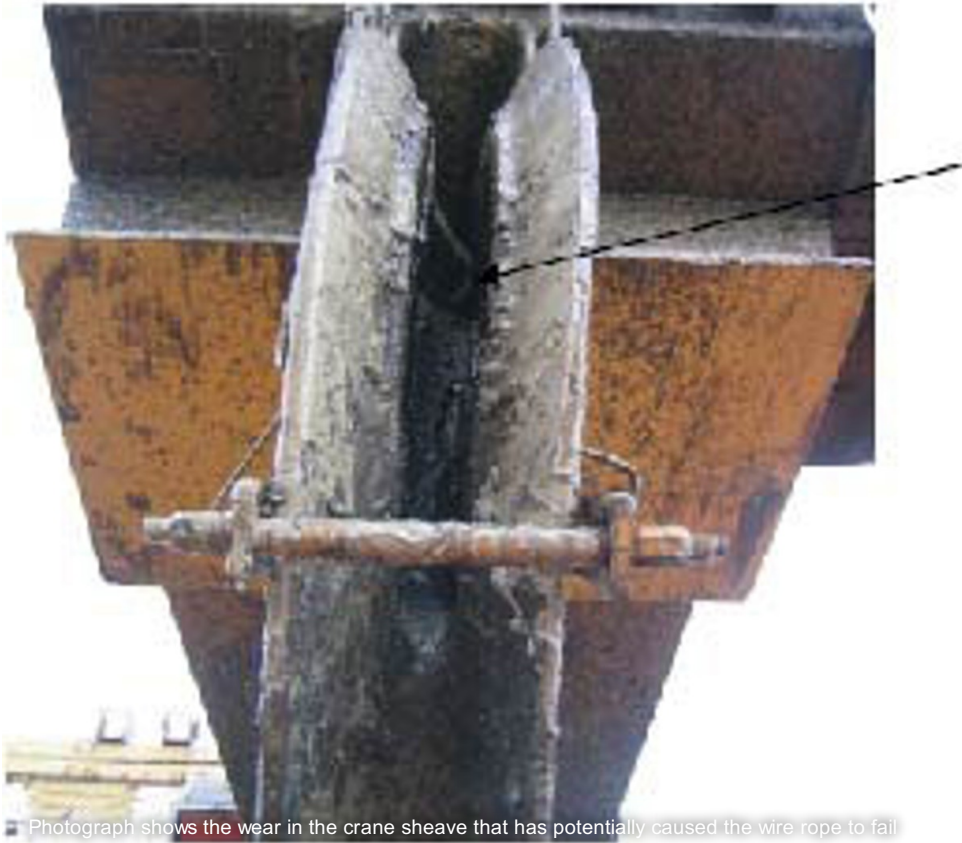
Immediate investigation identified the failure point of the wire rope to have been at the second sheave of the knuckle boom. Subsequent inspection of the sheave has identified significant damage that would be consistent with the sheave failing to rotate during the operation of the crane, and the resultant wear on the wire rope is potentially the cause of the rope failing.

Photograph shows the wear in the crane sheave that has potentially caused the wire rope to fail

It is recommended that members operating vessel's with cranes of this type carry out regular inspection of crane sheaves to identify any signs of wear that would indicate a potential failure of the sheaves to operate as designed. Members operating cranes with active heave compensation are recommended to check sheave integrity and visibly check rotation of all sheaves.
