Agitator started moving during mud tank cleaning – leading to injury

Safety Flash Published on 31 March 2020 Generated on 21 January 2025 IMCA SF 12/20

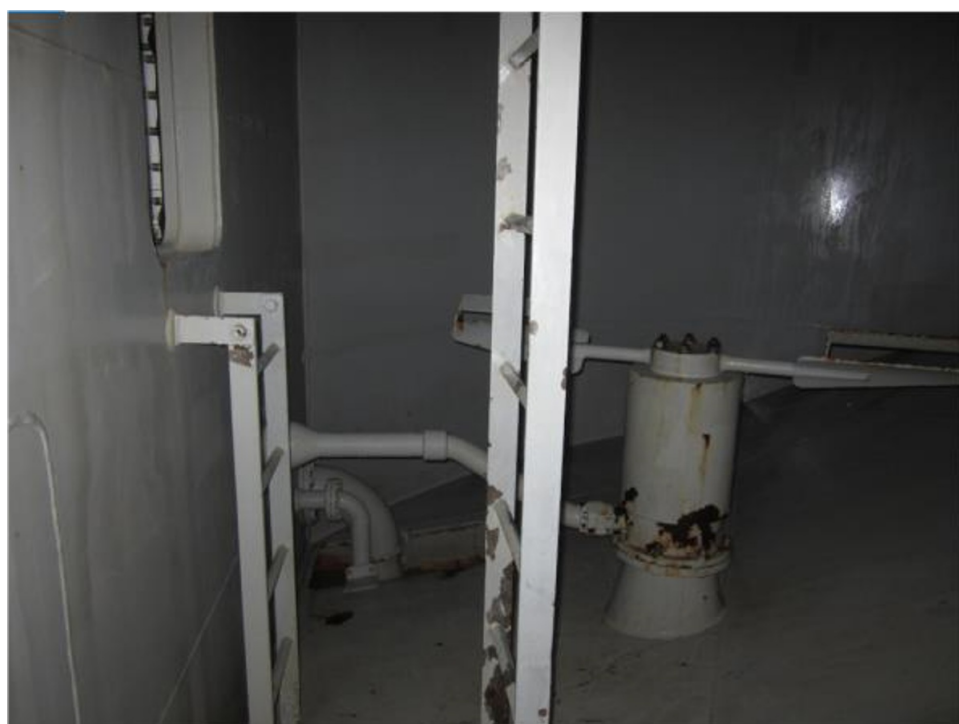
An agitator in a mud tank started up when an employee of a third-party contractor working in the tank was in the way. He was hit by the agitator paddle in his lower back and fell to the tank floor.

As the last of three tanks was being washed, the agitator (42 rpm) suddenly started with one person inside the tank.

The person was hit by the agitator paddle in his lower back and fell to the tank floor. He had his back to the agitator at the time and didn't notice it starting. He managed to climb out of the tank by himself and was transported to hospital by ambulance. He was discharged the same day with bruises and one broken rib.

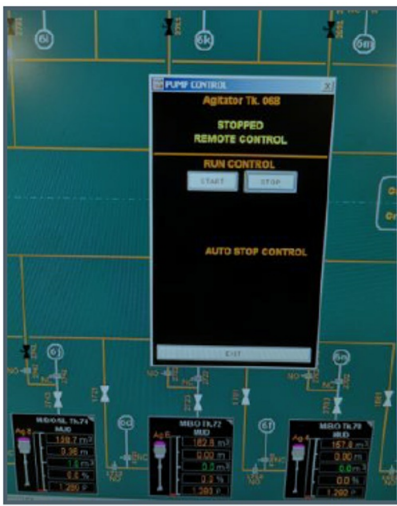
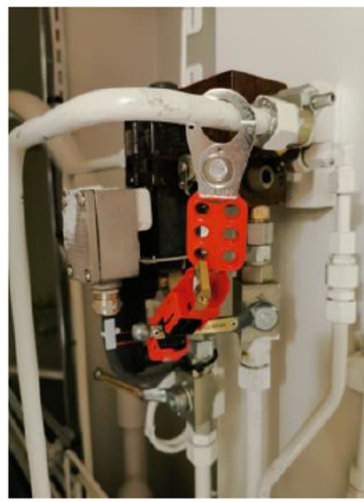
The agitators were stopped on bridge IAS only and had not been isolated or locked out.

Picture of bridge IAS control left and properly isolated control valve hydraulic flow right

- **Physical verification** that safety isolations and barriers, controls and lockouts are in place – double check.
- Focus on how to **improve compliance with existing procedures**.
- **Review relevant risk assessment**.
- **Better communication** between bridge department and engine department, particularly relating to tank maintenance operations.
- Improve isolation routines to include lock and tag and issuance of isolation certificate.
- Third-party tank washers will **improve their procedure** to include physical verification that agitators are properly isolated before entering

tank.
