## Crane boom stopper fell to main deck

Safety Flash Published on 16 May 2023 Generated on 23 January 2025 IMCA SF 12/23

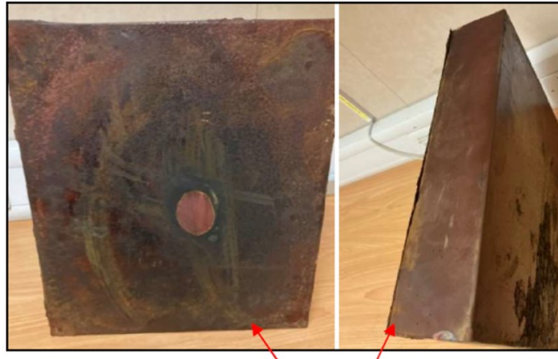
The rigging supervisor acting as banksman was in attendance, located on the inboard dedicated walkway. As the crane boom was slewing, the crane operator saw the boom stopper sliding down the knuckle boom and then falling to the deck.

The crane operator immediately sounded the crane horn. The boom stopper weighed 15.5 kg and fell 35 m.

- The area where the knuckle boom stopper pad landed was not a restricted area, access up and down the deck was via a dedicated walkway, inboard of the boom, 5 m away from where the boom stopper landed.
- The knuckle boom stopper pad was only attached to the backing plate by adhesive and then the backing plate bolted to the boom stopper frame structure.

Pad landing point - Banksman Position

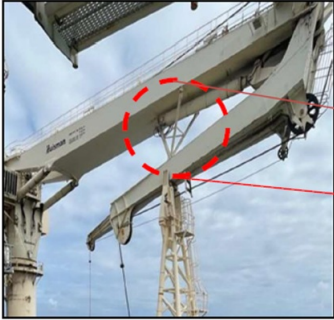
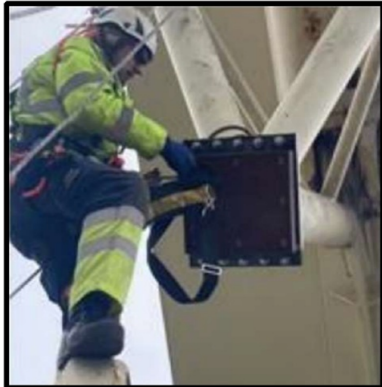
Knuckle boom pad

- Vessel technicians modified the backing plate by securing the boom stopper pad with 8 x M16 countersunk cap screws, Loctite and centre dab, and then it was reinstalled by a rope access team.
- The metal backing plate was secured with M20 bolts using nyloc and Loctite, preventing any repeat of the boom stopper becoming detached.

- There is potential for similar incidents to happen on other vessels, in areas where access to potential dropped objects is difficult. Check and see:
  - If any other cranes use the same or similar type pads and if so, ensure alternative or additional fixings are applied to any connections solely reliant on adhesive compound bonding.
  - Identify equipment and structures that present a risk of dropped objects and cannot be easily accessed for inspection and determine the best means of safe access and an appropriate frequency of inspection.
  - Verify if there is an existing work order or dropped object check list to cover these items and add/update as necessary.
