Lost time injury (LTI): Thumb injury

Safety Flash Published on 25 November 2011 Generated on 12 January 2025 IMCA SF 13/11

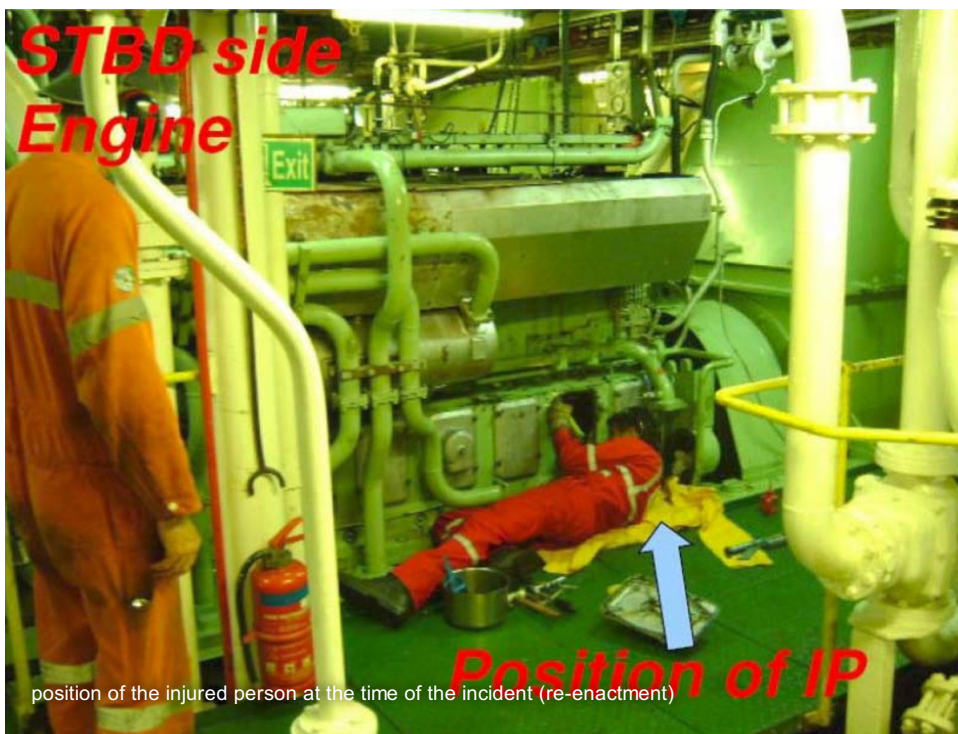
As another crew member started hauling up on the chain block, lifting the piston and connecting rod, the injured person found his left thumb trapped between the bottom of the cylinder liner and the bottom of the connecting rod. He motioned with his free hand to lower the load which allowed his injured thumb to be released. He then reported to the medic where, following a medical examination, he was subsequently medevaced ashore.

- Control and co-ordination of the task was reduced due to the difficulty in clear communication.
- This lack of control and co-ordination during the operation allowed the load to be moved while the injured person had his hands on the connecting rod.

- The crew member controlling the load by means of the chain block had no clear line of sight to the injured person whose hands were inside the engine.

- Incorrect positioning of hands
- The injured person's thumb was in the pinch point during movement of the

load.

- Review relevant task related risk assessments to ensure all associated and potential hazards are clearly identified and recorded.
- Ensure all lifting equipment is correctly rated and inspected for the intended task prior to use.
- Communicate the importance of toolbox talks and safe working practices to ensure key hazards are identified, discussed and addressed.
