Fire hydrants fitted with incorrect coupling size

Safety Flash Published on 21 September 2015 Generated on 21 January 2025 IMCA SF 13/15

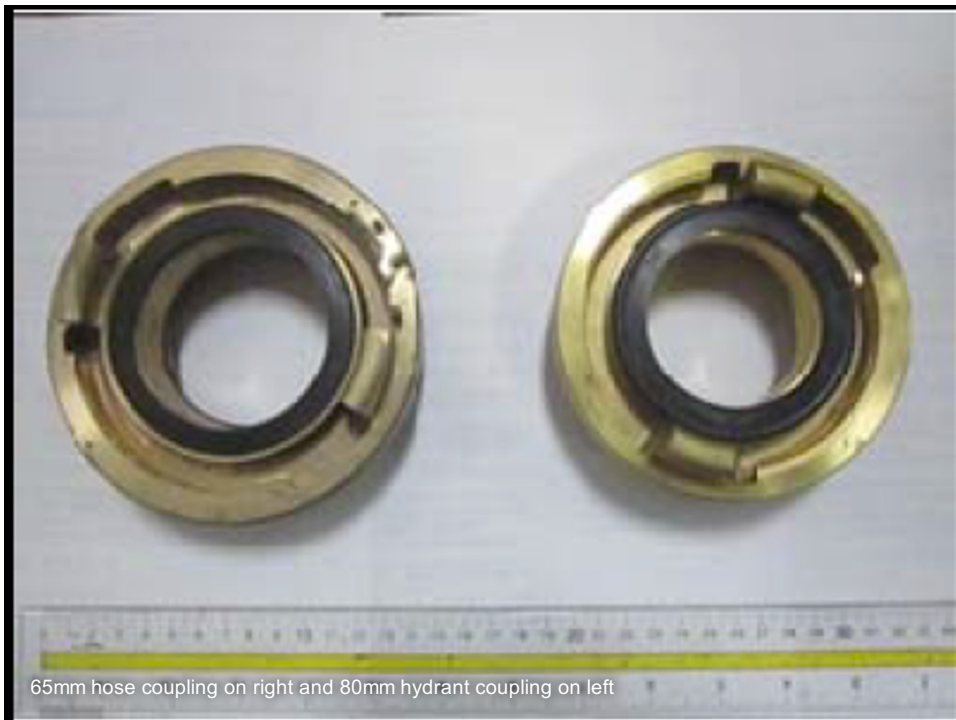
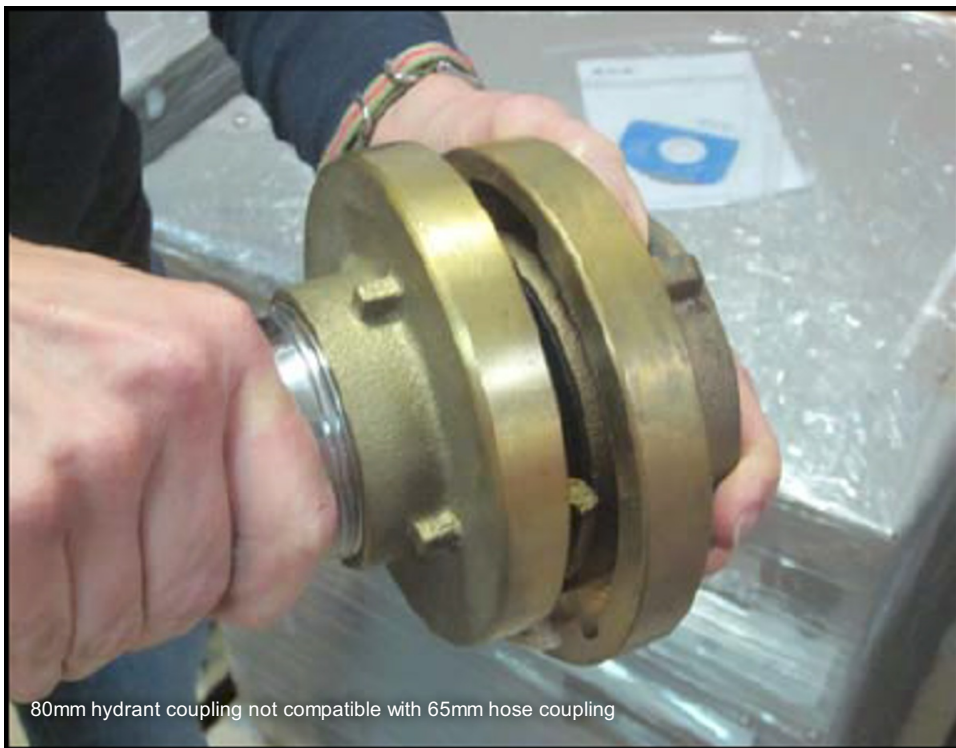
It was found that the coupling on the hydrant valve in the port side forward thruster room did not fit the adjacent fire hose coupling. The hose coupling measured 65mm and the hydrant coupling measured 80mm.

- The hydrant/hose coupling incompatibility was not followed up in a timely manner. Six days elapsed between the discovery of the incompatibility and a Hazard Observation being made.
- A total of thirty hydrant couplings were found with 80mm couplings fitted instead of 65mm couplings. Had there been a fire these thirty couplings (incompatible) on the fire hydrants would not have been serviceable.

Members may wish to check their own fire-fighting equipment, to carefully and thoroughly inspect all equipment when first received, and to ensure that during fire drills, hoses are properly run and connected to hydrants, including in the accommodation areas.
