## MAIB: Gantry crane wire parted causing injury

Safety Flash Published on 12 June 2023 Generated on 21 January 2025 IMCA SF 14/23

A gantry crane hoist wire parted causing a load to drop, causing injury and damage to equipment.

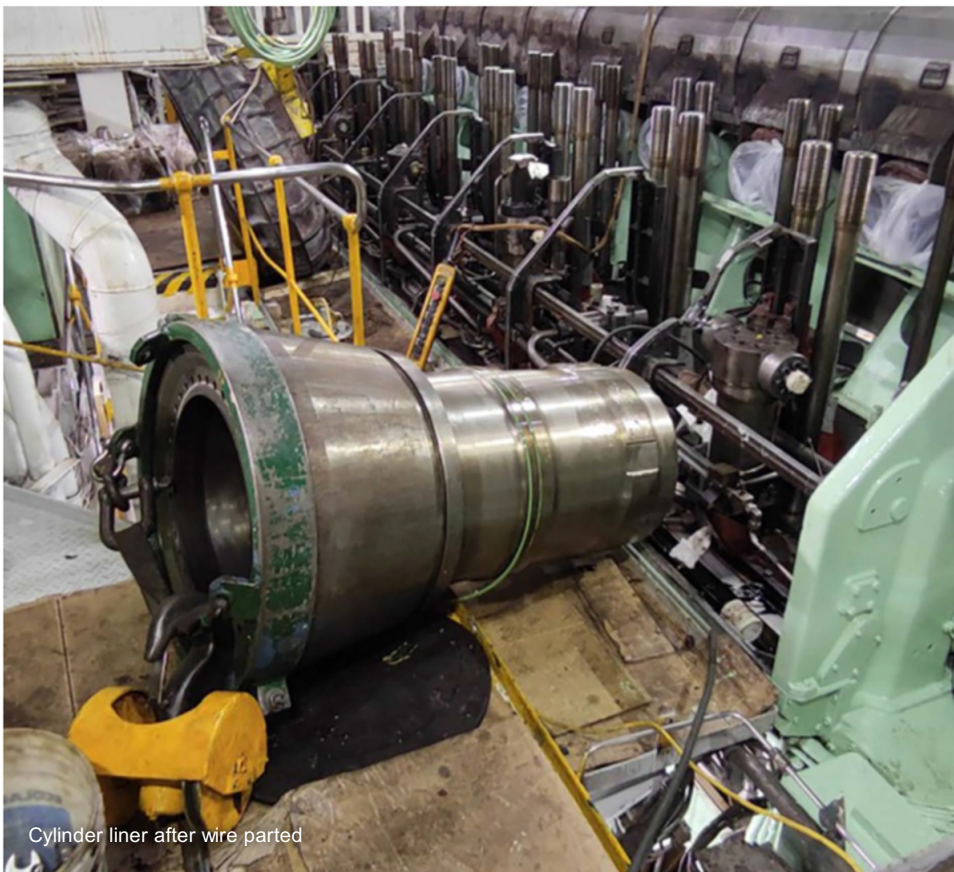
The suspended cylinder liner fell onto the engine, causing damage to both pieces of equipment, and struck the left foot of an engine room fitter who was standing nearby.

Cylinder liner after wire parted

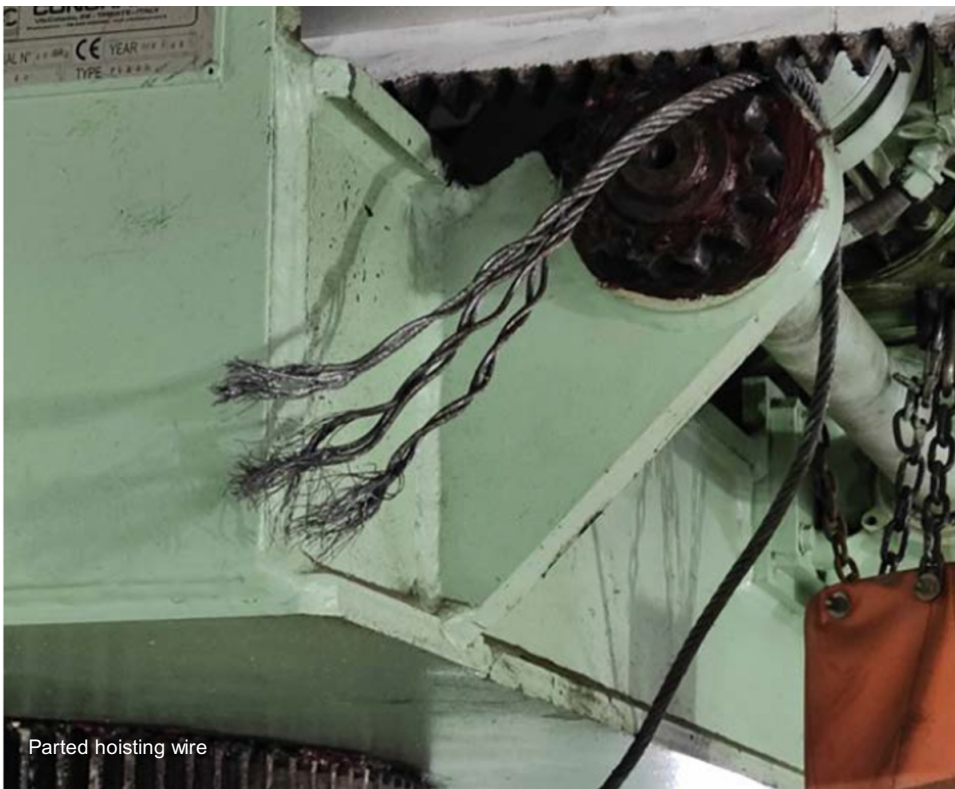
This required the electric winch motor to raise the crane hook to its maximum lift height, at which point the crane's hoisting wire suddenly parted.

Parted hoisting wire

- The crew member was in the line of fire, near or under a suspended load.
- The failed hoisting wire had been recently renewed but was found to be 7 m shorter than the wire length specified by the crane manufacturer. The shorter length wire affected the operation of the crane's hoist limit switch and prevented it from cutting power to the winch electric motor when the hook was raised to the maximum lift height; the winch motor was therefore able to overload the wire and cause it to fail.
- It was found that the same potential fault was extant on the other engine room cranes. The wire length recorded in the ship's planned maintenance system (PMS) computer was found to be incorrect when compared with the manufacturer's specification.

- The cranes were all taken out of service for repair. Engineers conducted a full inspection of engine room hoisting devices and take necessary steps to ensure that all equipment meets manufacturer specifications.
- Test hoist limit switches before operating cranes.
