## Davit hook failures

Safety Flash Published on 21 June 2023 Generated on 28 January 2026 IMCA SF 15/23

A member reports two separate instances where a workboat davit hook, and life raft davit hook components, have failed.

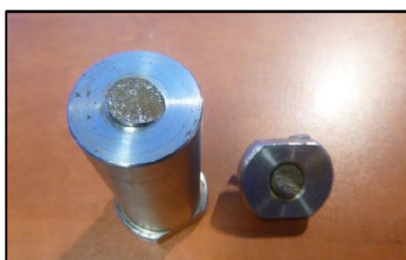
**Image 2** - Davit Hook Top Shaft failed (vessel 2)

- **Incident 1:** The failure of the workboat hook remains under investigation. Further information will be distributed when the review has been completed.
- **Incident 2:** The failure of the life raft davit hook was suspected to have been the result of an undetected crack in the threaded section of the hook top shaft screw. This allowed environment conditions to cause deterioration, resulting in the top hook shaft threaded section to shear off the body of the pin. Examination of the shaft showed that the fracture had developed over time.

- Halted all non-emergency launch and recovery operations using this type of hook until further notice.
- Inspected all similar davit hooks, paying particular attention to the top and bottom pin shafts and surrounding mounts, inspecting for cracks, deformation or fatigue. For this type of hook, the inspection included disassembly of the top shaft, loosening the securing screw, nut, shaft itself and the distance bush.
- Reviewed onboard maintenance regimes to ensure inspections of davit hooks include checks on the davit hook pins to identify any physical deterioration.
- Confirmed that the most recent annual inspection completed by the original equipment manufacturer (OEM) or third party included the opening of the hook and removal of the pin for inspection.
