Lost time injury (LTI) to leg

Safety Flash Published on 22 December 2009 Generated on 17 January 2025 IMCA SF 18/09

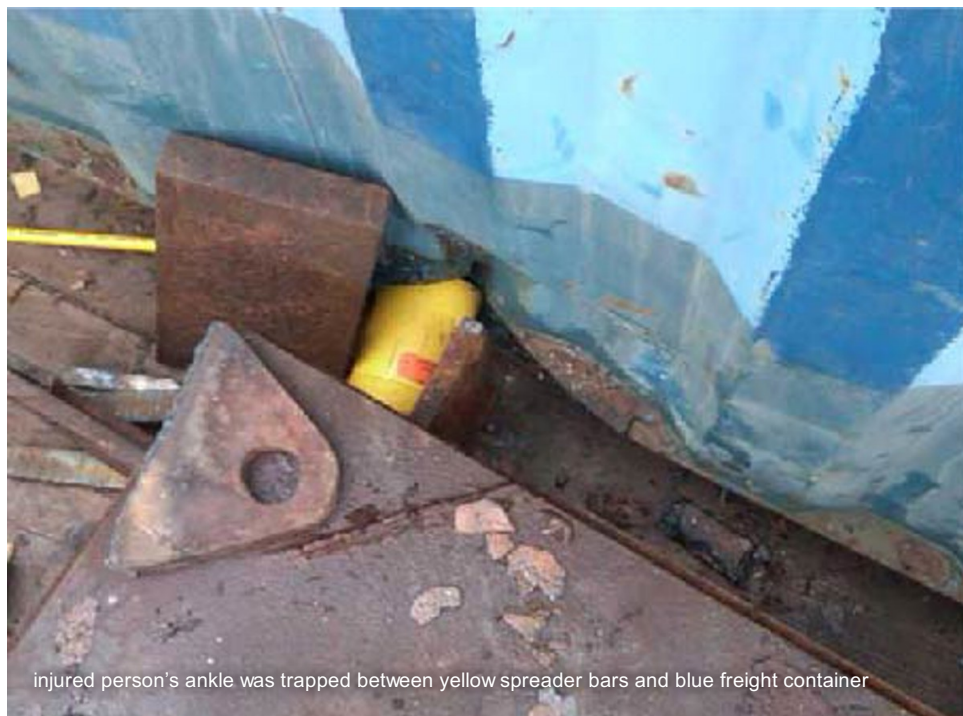
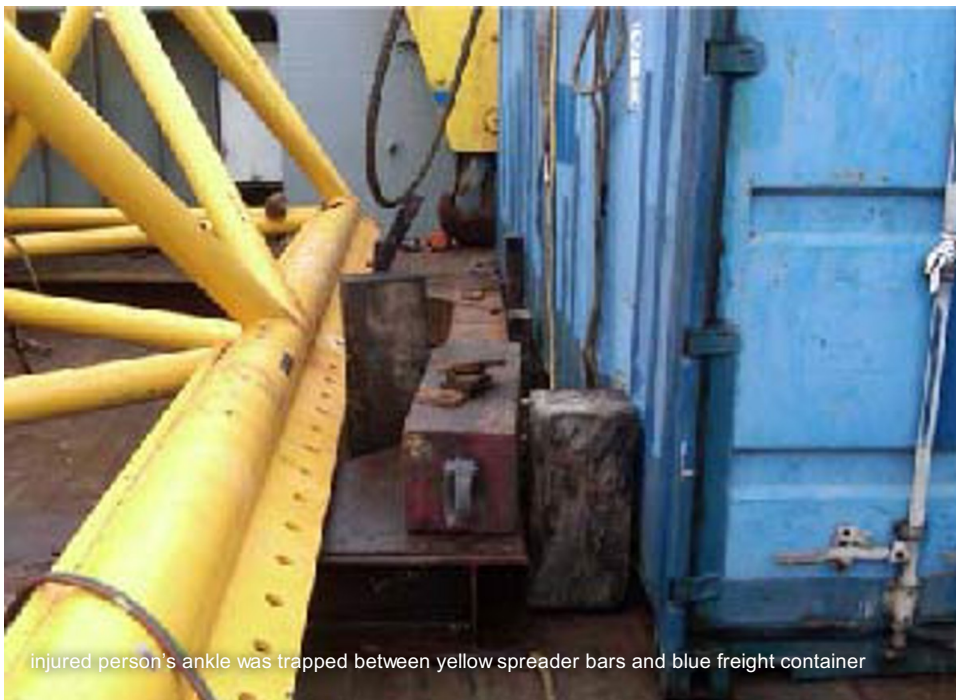
Whilst working on offloading a vessel, the sub-contract employee's left leg above the ankle was pinned between a shifting spreader bar frame and a freight container located adjacent to the spreader bar frame.

While one of the seven spreader bars was being lifted and in the air the remaining bars shifted, causing the frame to slide approximately one metre (40 inches) towards the freight container where the employee was standing.

injured person's ankle was trapped between yellow spreader bars and blue freight container

- The supervisor in charge did not follow in-house job safety analysis procedures.
- The sub-contractor personnel were not required to follow in-house job safety analysis procedures.
- The sub-contractor did not provide the specified fully trained personnel but rather a general labourer.

- Installation of clips to secure the load frames to the deck and installed additional safety stops on the load frames to hold the spreader bars from moving.
- Audit of training records of all sub-contractor personnel in order to ensure that personnel without proven competence or proper training were not accepted for work.
- The sub-contractor was asked to provide full training for all contract personnel, which should be:
 - appropriate to the work being performed
 - compliant with local regulatory safety standards
