Fire in the accommodation: electronic items in cabins

Safety Flash Published on 23 August 2018 Generated on 28 January 2026 IMCA SF 18/18

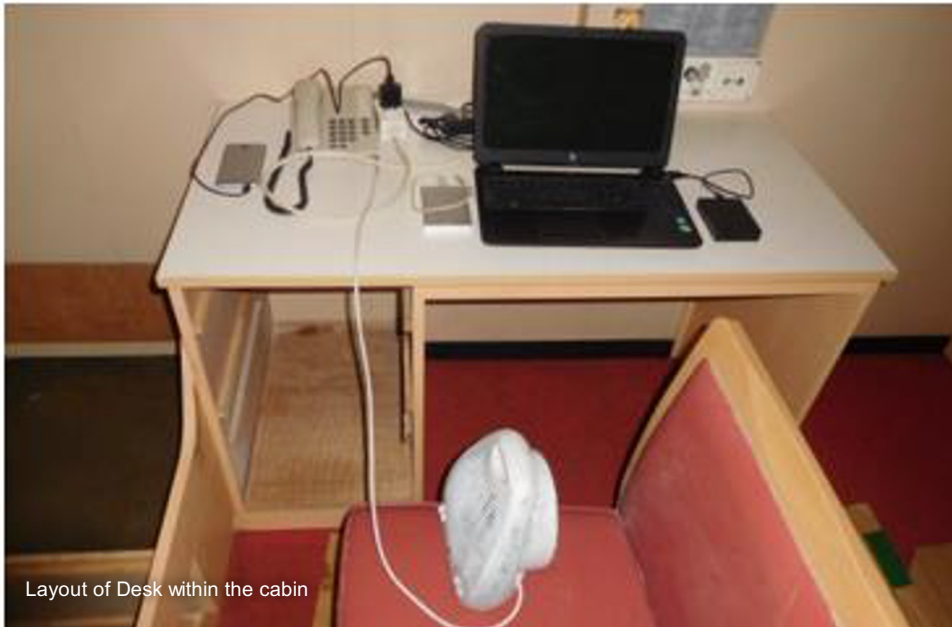
A crew member finished his work for the day and returned to his cabin. He plugged his mobile phone into an extension cable to charge; also plugged into the extension cable was a fan heater. He then proceeded to his bathroom to wash.

Layout of Desk within the cabin

The crew member emerged from his bathroom to find his cabin filled with smoke and a fire on the desk; both the cabin telephone and extension cable were burning. The crew member attempted to extinguish the fire by hitting it with a pillow, at this point the cabin telephone exploded and fragments fell onto the mattress, starting a second fire. The crewmember left his cabin.

- Electrical equipment was not used properly:
 - there was overloading of an extension cable/multiplug.
 - a number of electrical items (including high powered items) were plugged in and left unobserved.
 - heaters, fans and extension cables/multiplugs were bought locally by vessel crew from different sources, with no quality control check in place.
- There was poor housekeeping:
 - the heater was placed on the chair and electronic equipment all laced together along with wires and extension cables on the desk.
- The vessel air conditioning and heating equipment were not being used for controlling cabin temperature.
- The initial reaction of the crew member to attempt to smother the fire with a pillow caused the fire to spread and become more serious.

- Add requirement for PAT testing to vessel SMS and planned maintenance system (PMS).
- Implement more appropriate control of personal electronic equipment on board.
- Investigate and repair vessel air conditioning to ensure that accommodation temperature control using fixed vessel equipment is achievable.
- Post appropriate warning signs by sockets in cabins.
- Retraining and familiarization of crew on fire prevention on electrical equipment, raising the alarm and electrical safety in general.

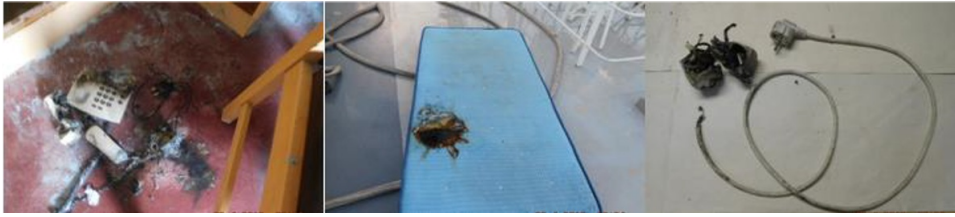
Fire Hazard

**Unplug any charging devices
before leaving the cabin.**
