Fire in the accommodation: electronic items in cabins

Safety Flash Published on 23 August 2018 Generated on 23 January 2025 IMCA SF 18/18

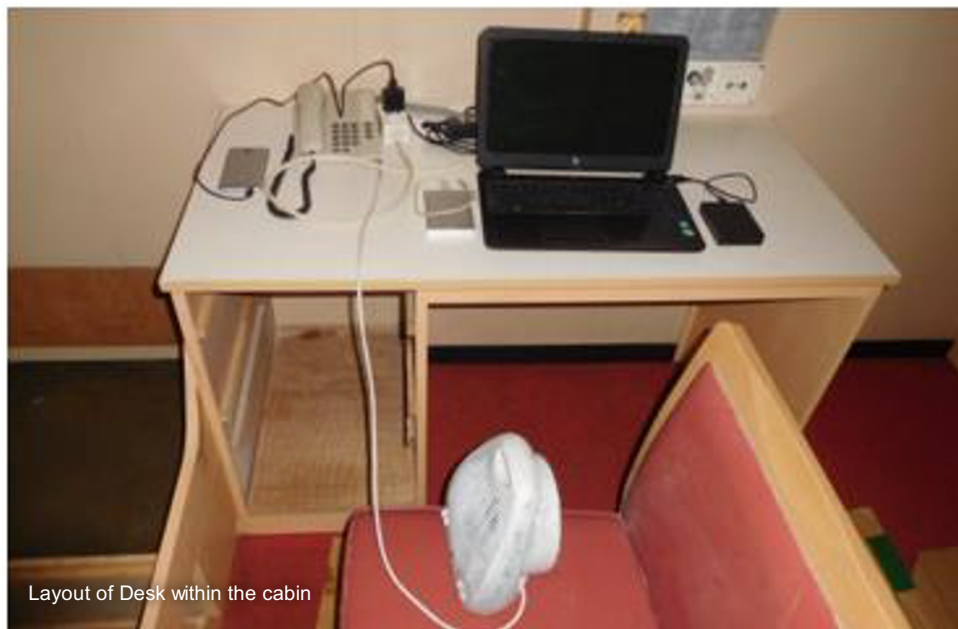
A crew member finished his work for the day and returned to his cabin. He plugged his mobile phone into an extension cable to charge; also plugged into the extension cable was a fan heater. He then proceeded to his bathroom to wash.

Layout of Desk within the cabin

The crew member emerged from his bathroom to find his cabin filled with smoke and a fire on the desk; both the cabin telephone and extension cable were burning. The crew member attempted to extinguish the fire by hitting it with a pillow, at this point the cabin telephone exploded and fragments fell onto the mattress, starting a second fire. The crewmember left his cabin.

- Electrical equipment was not used properly:
 - there was overloading of an extension cable/multiplug.
 - a number of electrical items (including high powered items) were plugged in and left unobserved.
 - heaters, fans and extension cables/multiplugs were bought locally by vessel crew from different sources, with no quality control check in place.
- There was poor housekeeping:
 - the heater was placed on the chair and electronic equipment all laced together along with wires and extension cables on the desk.
- The vessel air conditioning and heating equipment were not being used for controlling cabin temperature.
- The initial reaction of the crew member to attempt to smother the fire with a pillow caused the fire to spread and become more serious.

- Add requirement for PAT testing to vessel SMS and planned maintenance system (PMS).
- Implement more appropriate control of personal electronic equipment on board.
- Investigate and repair vessel air conditioning to ensure that accommodation temperature control using fixed vessel equipment is achievable.
- Post appropriate warning signs by sockets in cabins.
- Retraining and familiarization of crew on fire prevention on electrical equipment, raising the alarm and electrical safety in general.
