Incorrect pressure gauge on high pressure supply line

Safety Flash Published on 11 August 2017 Generated on 28 January 2026 IMCA SF 20/17

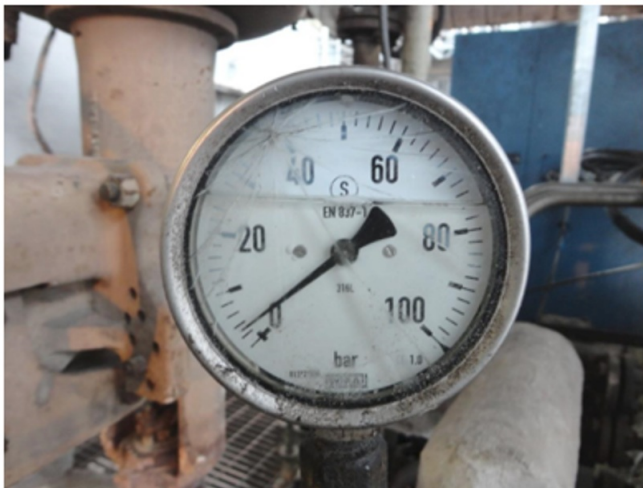
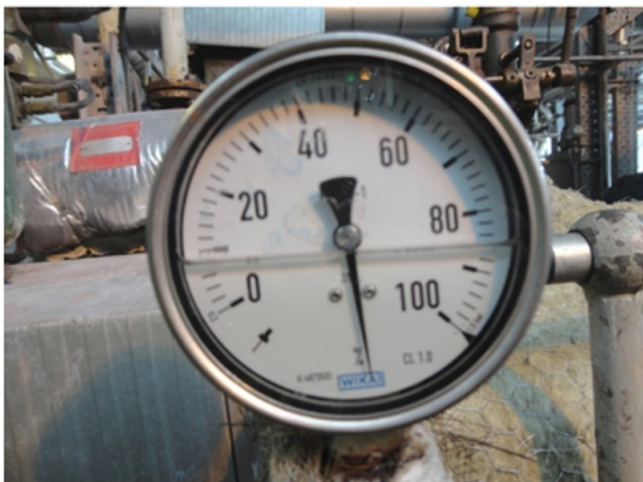
An incorrect gauge was installed. The pressure gauge was rated to one Bar(g) and the safety seal failed when it was exposed to 55 Bar(g) steam during re-commissioning. The pressure gauge in question was brand new and had been fitted during the recent maintenance period.

- The pressure gauge was inspected and found to be a “0-100%” gauge, where a “0-100 Bar” pressure gauge should have been installed.
- The 0-100% gauge had been ordered in error for a prior boiler shutdown and had been subsequently stored in the utilities equipment room, rather than returned to the warehouse for disposal.
- Technicians had established a culture of storing some small items in equipment rooms to allow easy access for small maintenance tasks.
- On the day of installation, the 0-100% gauge was mistaken for a 0-100 Bar pressure gauge (due to the near identical appearance) and was taken from the utilities equipment room and installed on the steam turbine high pressure steam supply line.

- Check all stores stock to ensure that all pressure gauges are stored in the correct place and in the correct boxes.
- Ensure that all unused equipment is returned to the place of issue at the end of each day. This ensures that only the correct equipment for a specific work order can be withdrawn.
- Ensure that all pressure gauges are function checked and fit for purpose before installation.
- Review stores stock items and material numbers to establish those that are no longer used or required. Block all numbers that are not required so as to prevent re-ordering by accident;
- For legacy assets, review and rationalise all local pressure gauges across each facility with a view to removing those that are no longer used or required.
