## NTSB: Crane wire failure

Safety Flash Published on 27 November 2024 Generated on 4 December 2024 IMCA SF 23/24

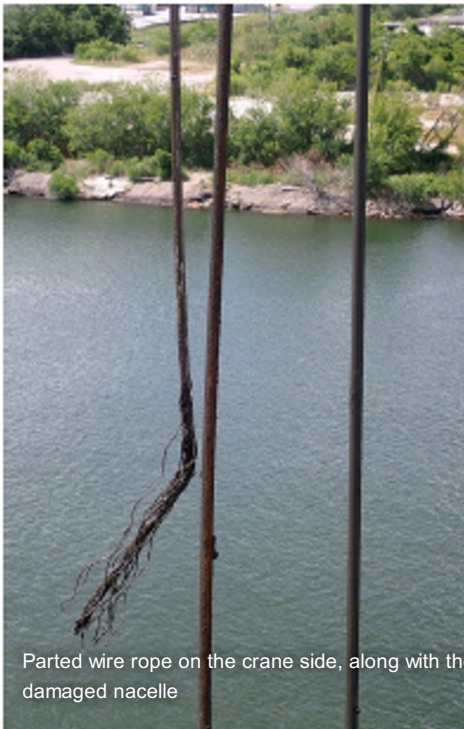
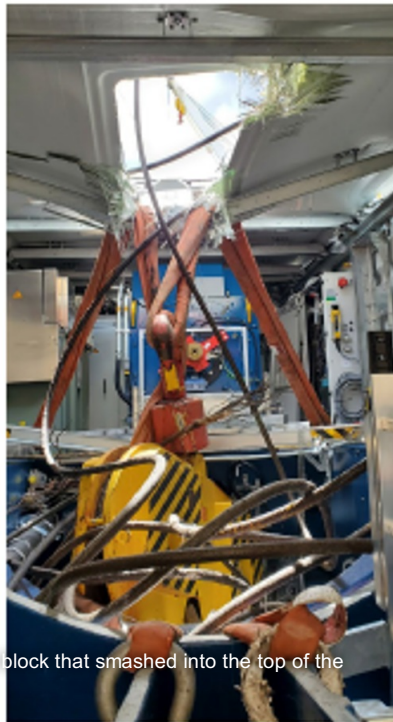
### Photo 1

Parted wire rope on the crane side, along with the crane block that smashed into the top of the damaged nacelle

The probable cause of the failure of the hoisting wire was undetected corrosion and wear in strand wires.

- Examination of the hoisting crane wire found significant external corrosion, as well as roughness and pitting, and “uniform corrosion of internal surfaces” of the hoisting wire rope. This corrosion and wear caused some of the individual wires comprising the strands of the hoisting wire rope to part when the crane lifted the nacelle unit, subsequently causing the strand and then the remaining wire strands to become overloaded and fail.
