Medical treatment: Person fell down unprotected hatch

Safety Flash Published on 12 October 2016 Generated on 18 June 2025 IMCA SF 27/16

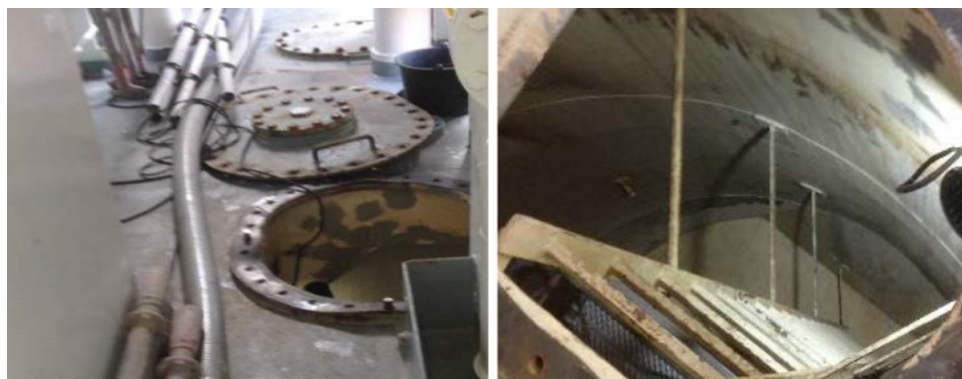
The MSF has published safety alert number 16-17 regarding an incident in which a shore-side foreman walked into the “safe haven” area of a supply vessel and stepped into an open manhole.

Whilst he managed to catch himself and prevent a free fall of 5m into the tank, he nonetheless suffered a laceration on his shin requiring 3 stitches and bruising to the forearm.

- Lack of barriers to open manholes.
- Several different activities all occurring at once.
- Lack of coordination of those simultaneous activities.

- Covering of manholes with gratings during work.
- Ensuring that ongoing work is coordinated between the work parties in the same area, through toolbox talks.
