Snagged load, a sling snaps, dropped objects: persons injured

Safety Flash Published on 1 October 2021 Generated on 28 January 2026 IMCA SF 27/21

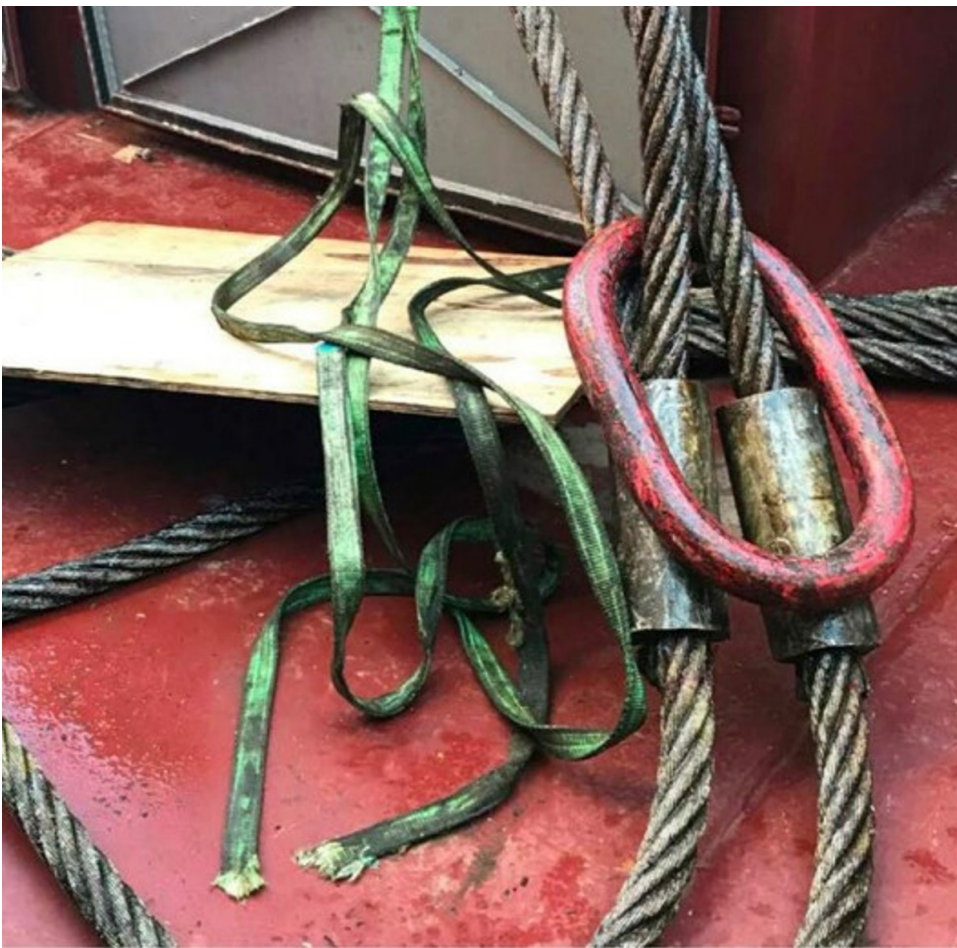
The incident occurred during the movement of the ship's hatch covers. The suspended load was lifting gear – two slinging sets; each set weighing 0.6t and consisting of two 17m long, 52-millimetre (mm) diameter, wire rope legs joined together with a master link. Each wire leg had a shackle attached to an eye at the lower end. The gear was to be used to move the ship's hatch covers.

During the lifting operation, a shackle at the lower end of the load became snagged. The supervising officer immediately instructed the crane driver to stop, but at the same time the fibre sling parted and the lifting gear fell to the deck, striking the A/Bs who were close below. One of the A/Bs suffered a severe head injury while the other suffered a minor hand injury. Both A/Bs were transferred to hospital.

The ship's Safety Management System (SMS) did not contain a specific risk assessment or a procedure for the stowage and handling of the lifting gear, nor any guidance for the conduct of a lifting plan and the identification of fall zones.

As there was no procedure to follow, the crew had adopted their own method of carrying out the lifting operation. The crew had used the same method on at least five previous occasions and had experienced similar snagging events. When these had occurred, the deck crew had manually freed the gear after the crane had stopped hauling.
