Two yard-based fatal road traffic accidents (UK HSE)

Safety Flash Published on 7 November 2017 Generated on 21 January 2025 IMCA SF 28/17

Incident 1: Worker fatally crushed between two articulated vehicles

Incident 2: Worker died after being struck by a reversing telehandler

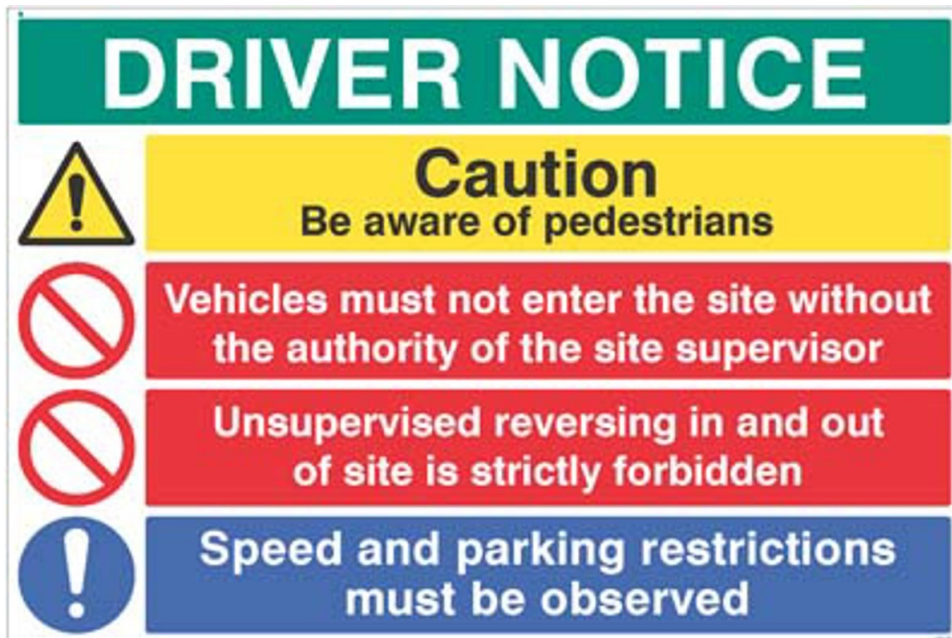
A driver suffered fatal injuries when his vehicle rolled forward out of control whilst he was coupling the HGV (heavy goods vehicle) tractor unit to a trailer. See press.hse.gov.uk for original press release.

UK HSE investigation found that the company had failed to implement safe systems of work or monitoring arrangements to ensure that its drivers were consistently undertaking coupling and uncoupling operations safely, in line with widely available industry guidance.

As a result of this, a culture developed whereby its drivers were not always

applying trailer parking brakes.

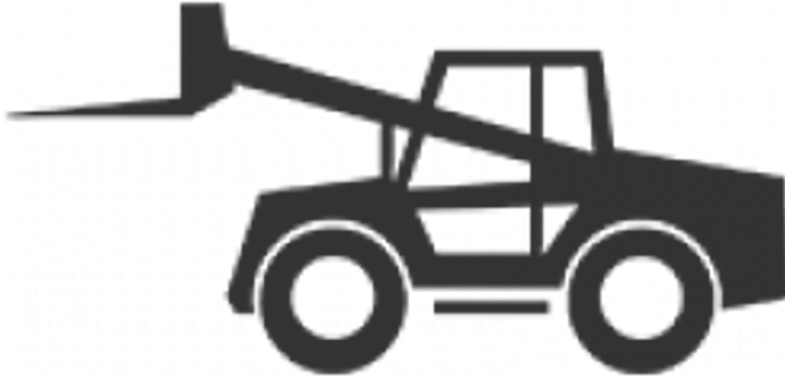
- A worker was struck by a reversing telehandler when crossing the work yard. The worker sustained multiple injuries and later died in hospital.
- See press.hse.gov.uk for original press release.

- The company had failed to address the management of large vehicle movements on its site.
- The company had not carried out an on-site health and safety inspection.
- The driver of the telehandler involved in the incident had not received any training in operating this vehicle.

"This was a wholly avoidable incident, caused by the failure of the company and its director to take simple steps. Vehicle movements...were not controlled even at a basic level at this company's site. The company failed to have adequate pedestrian segregation measures such as walkways or crossing points in areas where pedestrians walked routinely. Reversing of large vehicles near to pedestrians was commonplace. This was a dangerous mix which led to this tragic incident."
