Portable electrical equipment – serious fire in the accommodation

Safety Flash Published on 15 October 2021 Generated on 25 April 2025 IMCA SF 28/21

A Member reports a serious fire in the accommodation on a vessel at anchor.

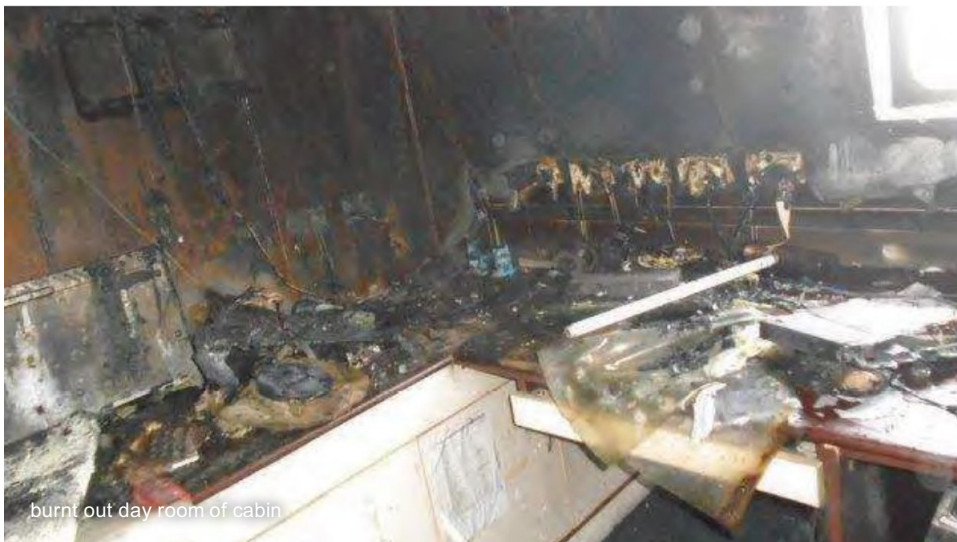
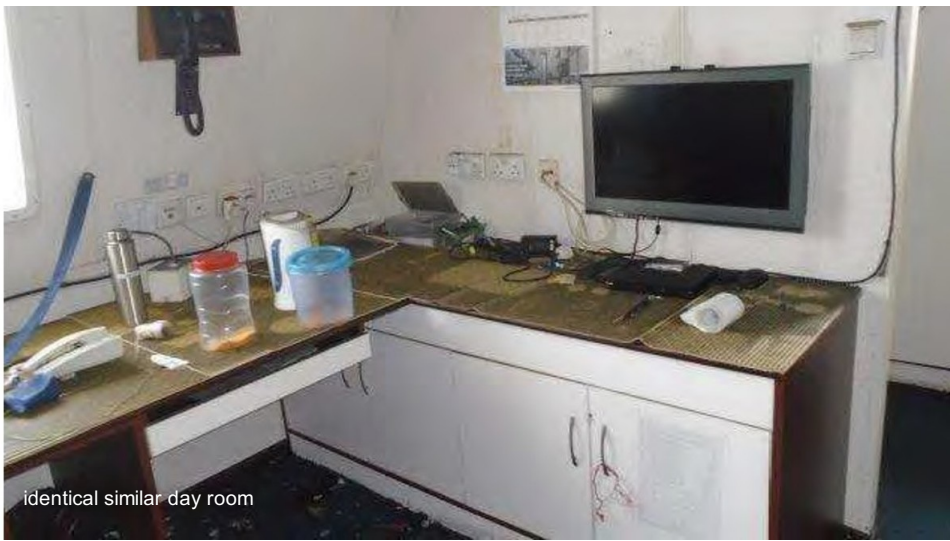
It was noted that first appearances showed the bedroom of the cabin to be completely damaged. The damage in the day room was much less. This had given the initial impression that the fire had originated from the bedroom. However investigation revealed that the fire had actually started from the day room.

Further investigation showed that the fire was caused by an electric kettle in the day room which had been left on while the occupant was not in the cabin. **There is a very high probability that the kettle cut-off safety switch did not operate.** This led to the overheating and caused smouldering eventual catching fire of the kettle handle and all the subsequent fire.

- Fire-fighting
 - A nearby cabin was identical in plan: an understanding of this cabin made the task of the fire-fighters easier.
 - The fire-fighters were unable to safely enter the burning bedroom, and the fire was attacked by breaking a port hole and inserting a fire hydrant.
 - It was found that fire-fighters with full beards were less able to fight the fire effectively owing to smoke leakage into their BA sets.
- Portable electrical equipment
 - Consider carefully the origin and quality of permitted portable electrical equipment.
 - What portable electrical equipment should, and should not, be permitted in cabins and elsewhere?
 - To what extent should such equipment be left powered while the cabin is unoccupied?
 - How is such equipment connected to the vessel mains (extensions, sockets etc)?
