## Two hand injuries

Safety Flash Published on 18 December 2023 Generated on 22 January 2025 IMCA SF 29/23

A Member reports two hand injuries.

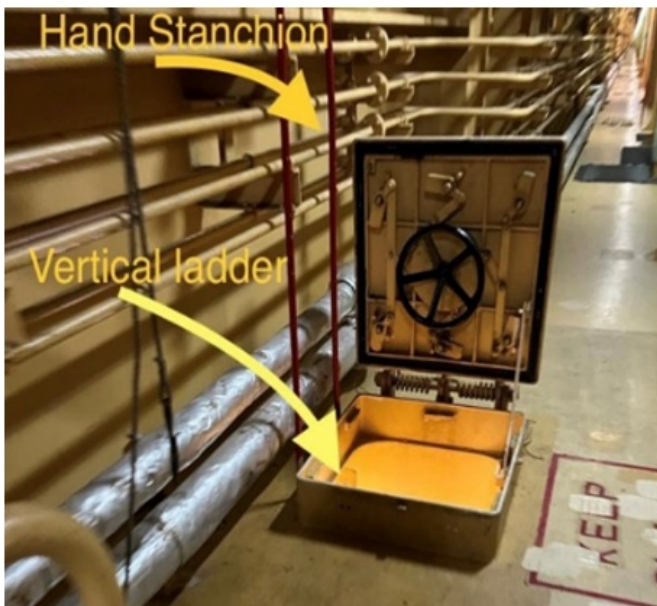
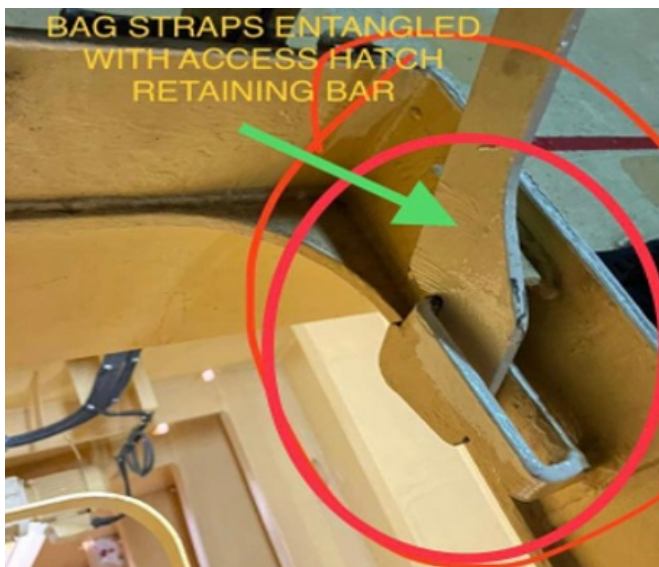
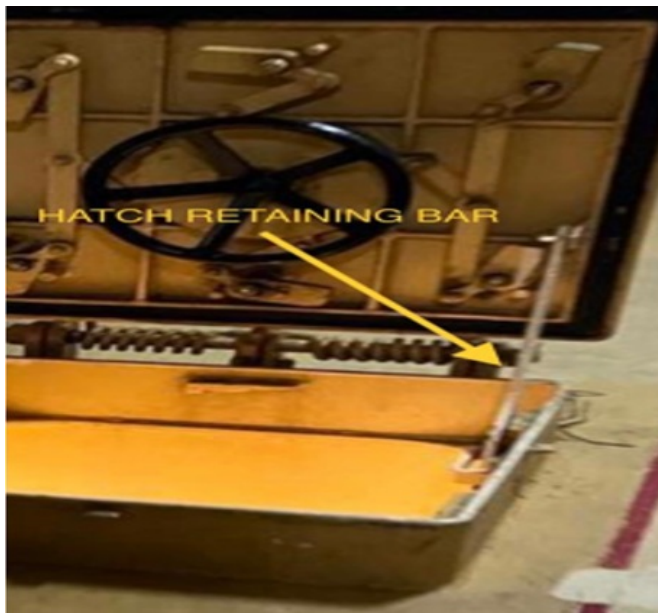
As a Pilot climbed the vessel's access hatch to the under-deck passage, his backpack straps entangled with the hatch retaining bar.

A sudden release of the hatch caused it to abruptly close, causing pain and swelling to the Pilot's right-hand knuckle.

- The access hatch retaining bar was not being properly secured and this was not noticed by the Pilot.
- A third-party vessel duty officer failed to check the access hatch and proper rigging arrangements before the Pilot boarded.
- The access hatch is too narrow to pass through with bulky bags and this hazard was not recognised by the vessel crew or the Pilot.

- Ensure that access hatches are properly secured.
- Heavy bulky bags or accessories carried by Pilots should be transferred separately.
- Better identification of hazards associated with routine and non-routine tasks.
- Better communication – can we keep in the line of sight and so keep out of the line of fire? What about a hand-held radio?

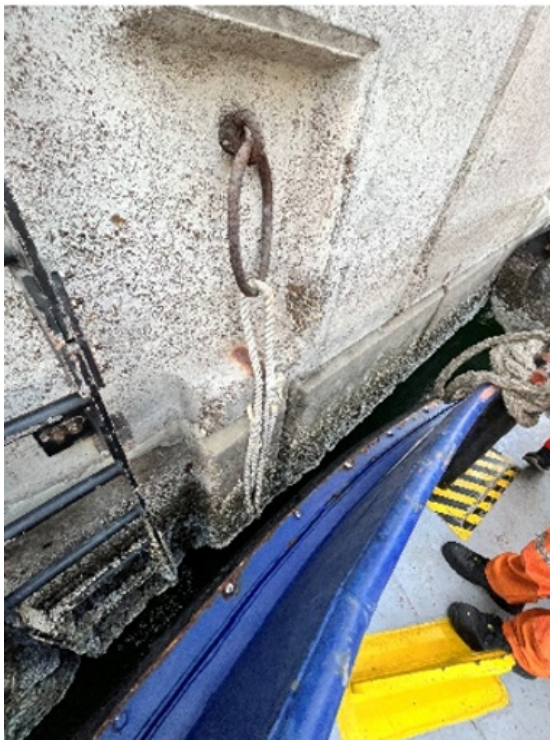
The sudden movement of a small boat caused a seaman's thumb to get caught between the fender and the quay, leading to injury.

The small boat was being moored alongside at a mooring ring. It was high tide, so the mooring ring was about 0.5 m below the bulwark of the boat.

As the boat approached the mooring ring, the seaman began securing the boat even though it was not yet hard up against the quay.

The bow of the boat moved unexpectedly, causing his thumb to get caught leading to a crush laceration injury.

- Lack of proper risk assessment and job planning – the team failed to identify hazards associated with routine & non-routine tasks. Pinch point hazards were not considered or documented in the task risk assessment.
- There was a lack of communication and no visual contact between the skipper and the crewman.
- There was a lack of PPE compliance – the injured person wore no gloves at the time, though this was a company requirement for this work.
