LTI: Finger injury during emergency recovery of ROV

Safety Flash Published on **27 November 2024** Generated on **4 December 2024** IMCA SF 23/24

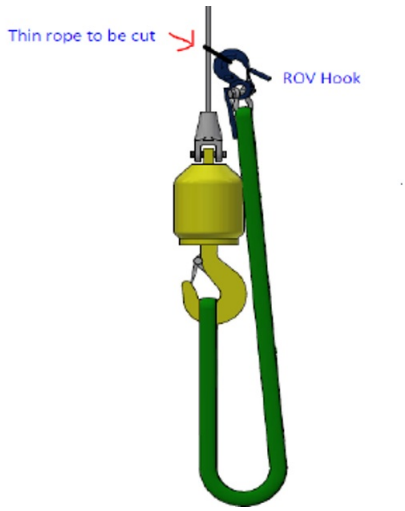
Photo

The worker successfully retrieved the emergency rigging on the ROV and attached it to the FRC by a securing rope. Then the FRC moved away from the vessel and the crane operator on the vessel started paying out wire and manoeuvring the rigging towards the FRC. However, before retrieving the crane hook, the worker had to release the ROV hook attached to the crane wire with a thin rope, using a knife. As the worker did so, their finger was pinched, resulting in an amputation down to approximately the nail bed on the left ring finger.

- The step of releasing the ROV hook from the crane wire was not identified as a step, hence it was neither planned for nor risk assessed.
- Once the emergency recovery had started, the steps that needed to be taken were not sufficiently detailed in the plan or procedure.
- Fault finding and repair of latching mechanism on LARS ought to have been attempted prior to emergency recovery.

- Reviewed and updated Emergency Recovery procedure and risk assessment relating to it.
- Ensured that sufficient detailed planning, risk assessment and task evaluation take place particularly for emergency operations.
- Established regular training in emergency recovery scenarios using the FRC.
