IMCA Safety Flash 01/19

January 2019

1 Confined Space Entry: Person Overcome by Fumes and Rendered Unconscious

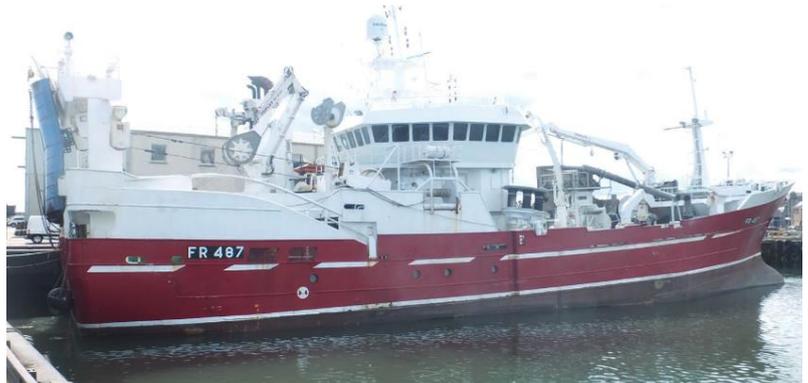
Fishing vessel Sunbeam

The second engineer entered a refrigerated saltwater tank (RSW) (which was being prepared for cleaning) and collapsed. He was seen lying unconscious at the aft end of the tank by a crewmate, who immediately raised the alarm. Three of the vessels' crew entered the tank and tried to resuscitate the second engineer, but they soon became dizzy, confused and short of breath. One of the crew managed to climb out of the tank unaided, the other two crewmen and the second engineer were recovered onto the open deck by two crewmen wearing breathing apparatus. The two crewmen made a full recovery, but the second engineer could not be resuscitated and died.

- ♦ Working in enclosed or confined spaces is potentially hazardous; procedures for entering and working in them should be robust, understood and utilised;
- ♦ Enclosed space rescue plans need to be in place on all vessels, risks must be understood, and rescue plans practised;
- ♦ All crew members have a responsibility for their own safety; this is particularly important in respect of lone working.
