# The Loss of the “Bourbon Dolphin” on 12 April 2007

Report from a Commission appointed by Royal Decree of 27 April 2007.  
Submitted to the Royal Norwegian Ministry of Justice and the Police on 28 March 2008.

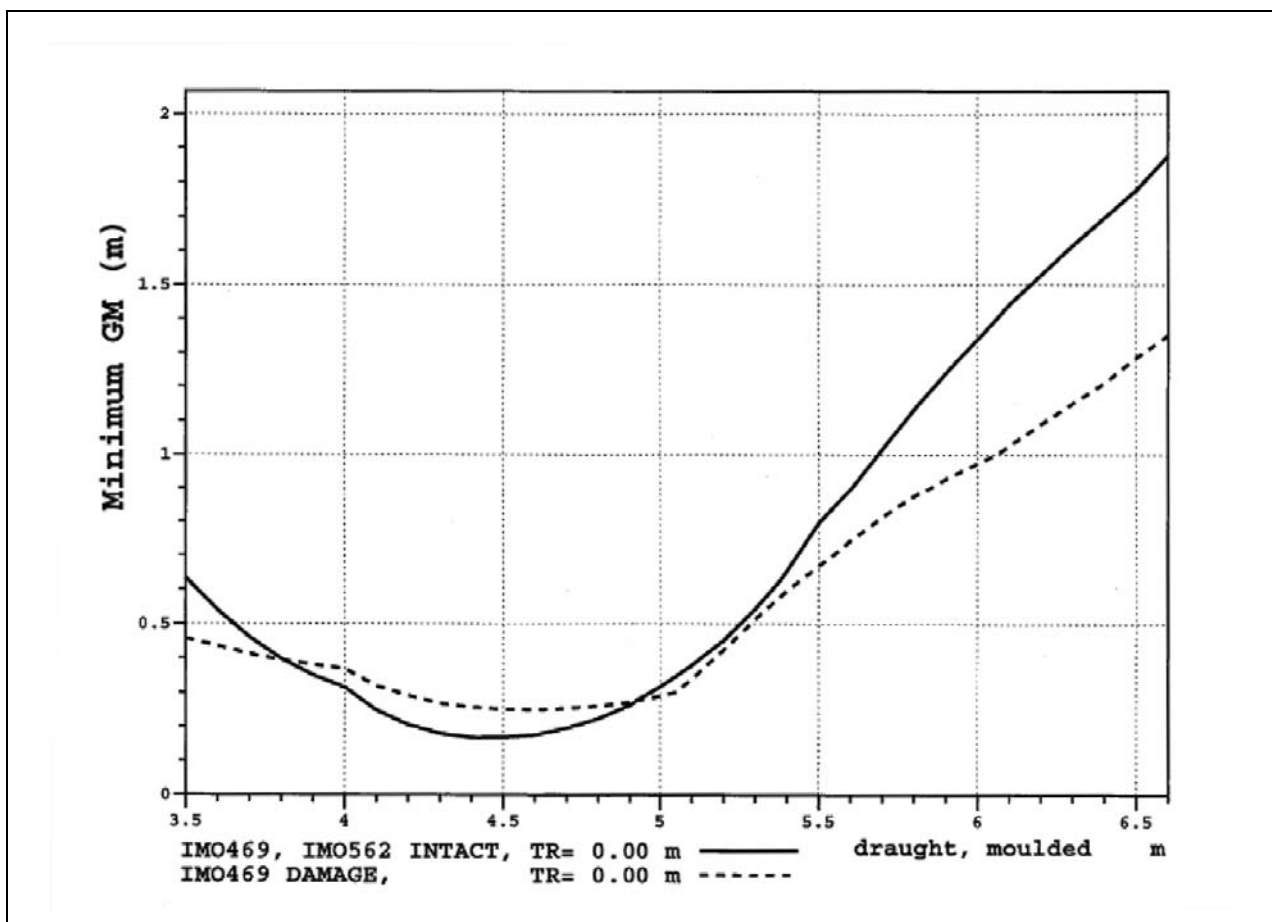
Figure 5.4 GM min curve

Curves are created for a set of trim values. The vessel's GMmin curves (one for intact and one for damaged stability) for trim = 0.0 m are shown in Figure 5.4.

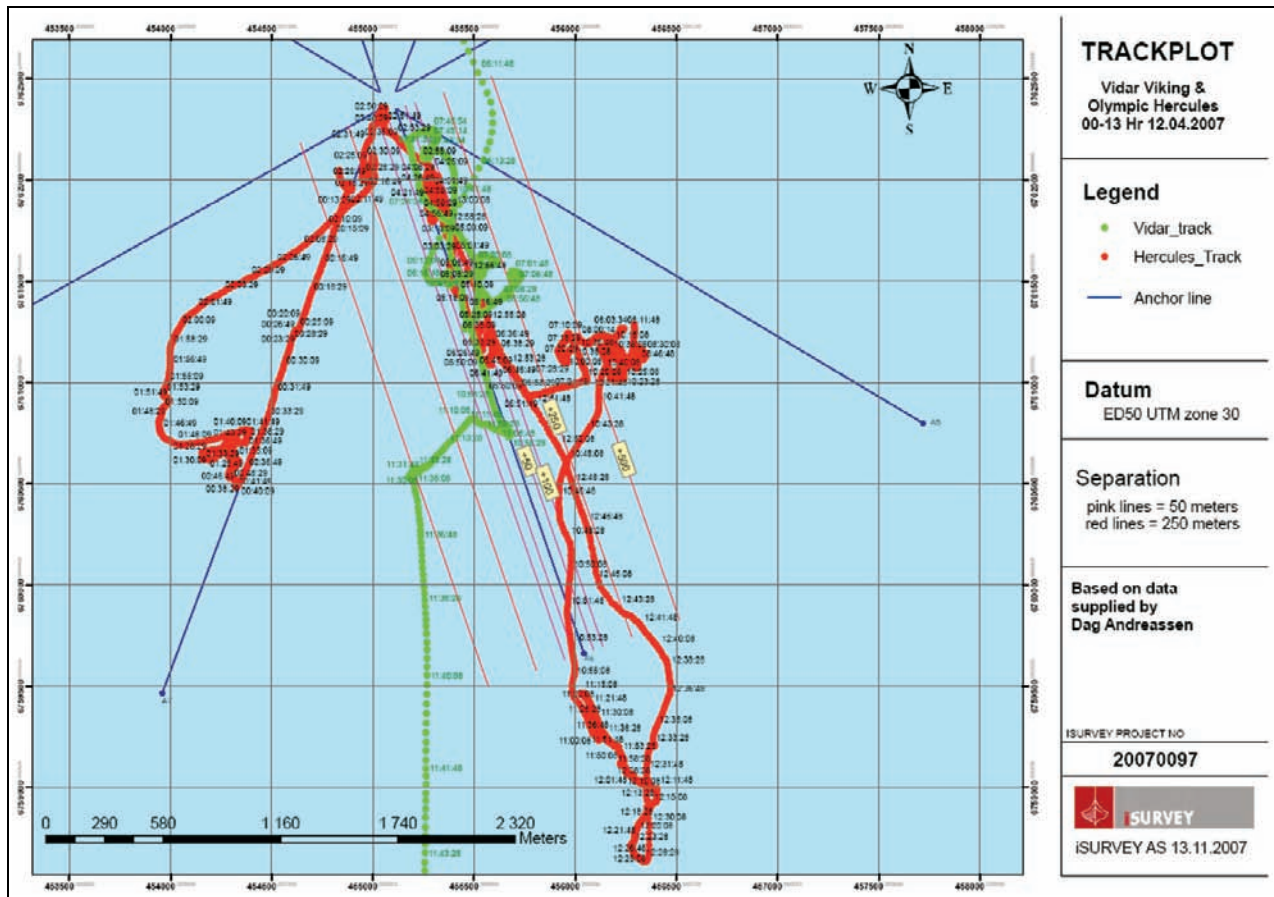
Figure 9.1 Trackplot for deployment of anchor no. 6

The “Olympic Hercules” did not manage to get back on track using her thrusters and rudder/propeller alone. At the worst, the “Olympic Hercules” had drifted about 730 metres east of line no. 6. According to Captain Grim Bergtun, the current was normally 2.5 knots, but that day was stronger.

The rig first asked the “Olympic Hercules” to wait, while the “Bourbon Dolphin” deployed anchor no. 2 together with the “Highland Valour”. The “Olympic Hercules” used her lateral thrusters on full (80 %), but was still drifting off, and so Captain Bergtun did not want to heave to and wait. Bergtun asked the rig to pay out its wire so as to give the “Olympic Hercules” speed for manoeuvring. The towmaster at first refused, but later granted the request, and wire was paid out from the rig’s winch.

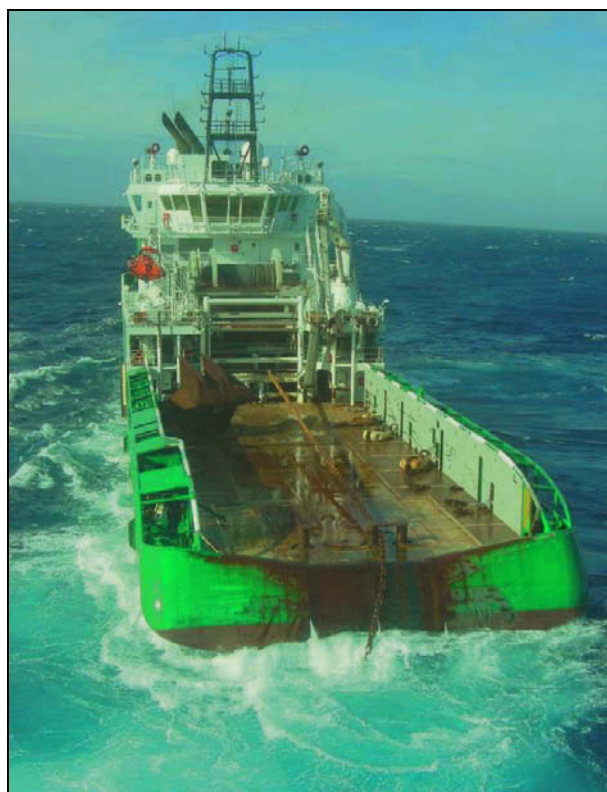
Figure 9.3 The “Bourbon Dolphin” at 16:31

12 April there remained the deployment of the last secondary anchor, anchor no. 2. This was a 18-tonne Bruce anchor, which the “Bourbon Dolphin” had taken on board in Lerwick on 9 April. The anchor was on deck, lashed to the cargo rail on port side, as shown in Figure 9.3.

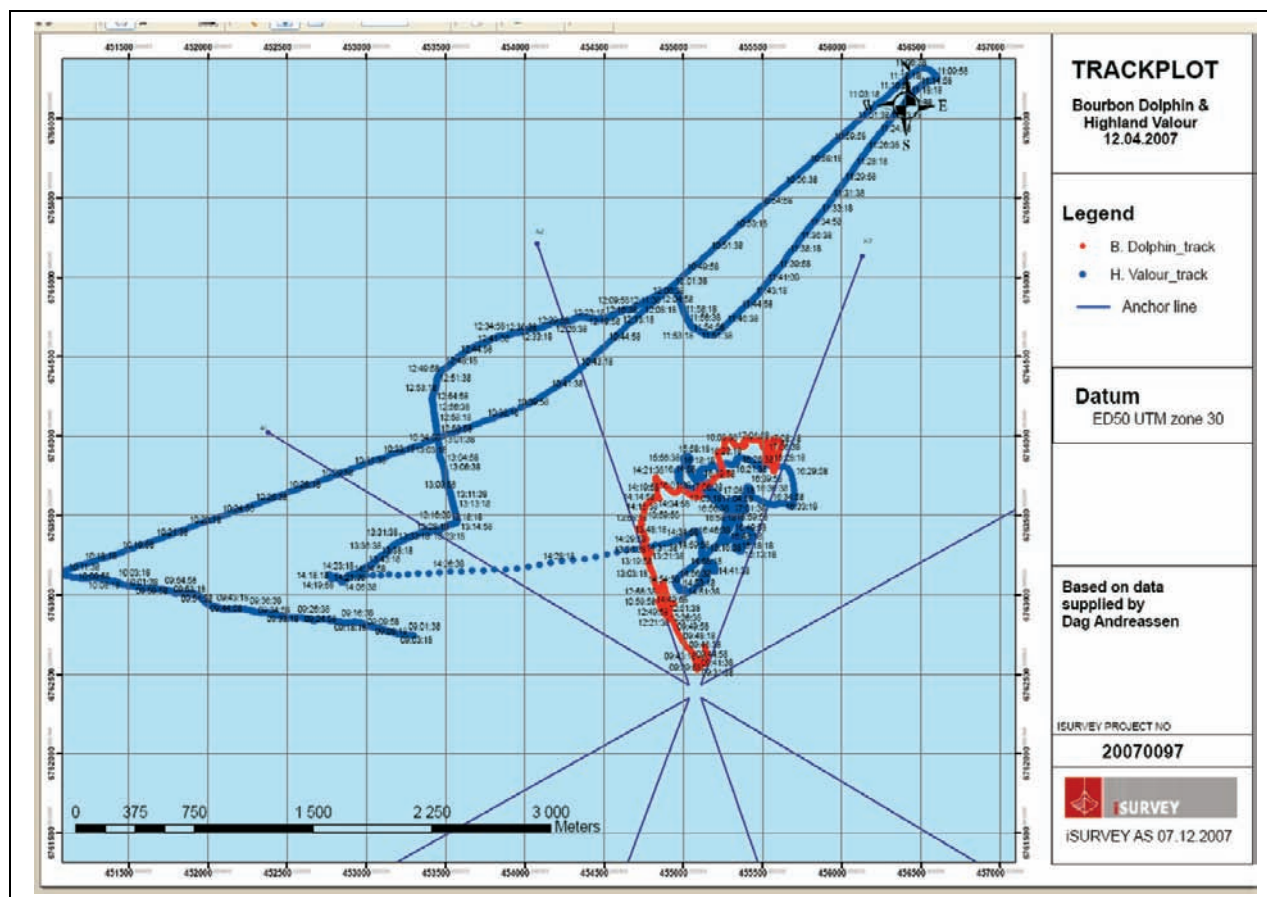
Figure 9.4 Trackplot for the “Bourbon Dolphin” and the “Highland Valour” 12 April

The “Highland Valour” proceeded westwards and hove to in a standby position from the “Bourbon Dolphin”, as shown in Figure 9.4. Chief Officer Dunlop testified that he registered that the “Bourbon Dolphin” had moved slowly west. Dunlop also testified that at one point, after the “Highland Valour” had gone standby, he heard the towmaster proposing that the “Bourbon Dolphin” connect workwire to her chain.

a probable direction for the vessel in order to reach her anchor station, see Figure 9.4.

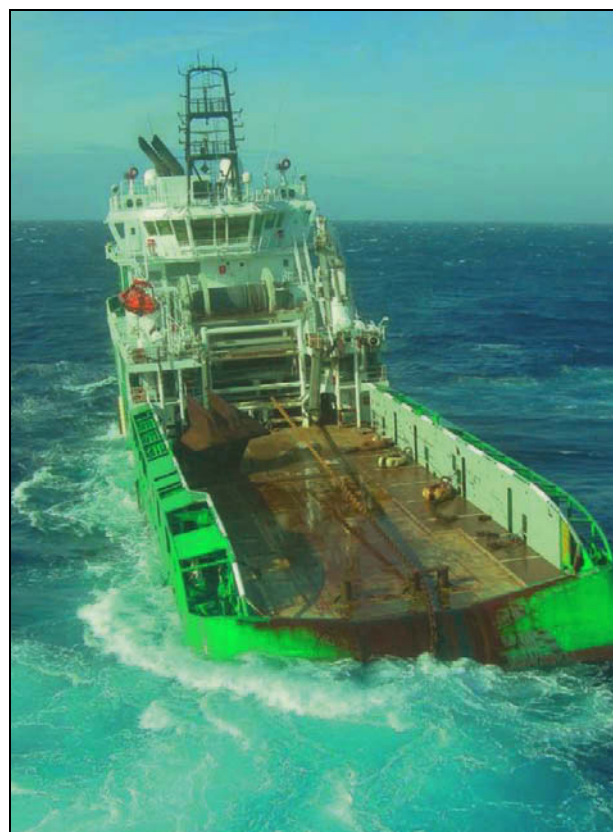
Figure 9.6 Picture taken at 16:31.

- Vertical:
  - 8.17 m over the vessel's baseline (top of the stern roller)
- Transversely:
  - 0.6 m to starboard when the chain is between the starboard towing-pins. In this situation the chain has an angle of attack to port and may easily be seen in figure 9.6.

Figure 9.6 [*sic*] shows that the angle of attack is perhaps 20-25 degrees. The calculations show that the vessel probably has a list angle of 2-3° even with small angles of attack. This is in line with statements from witnesses.

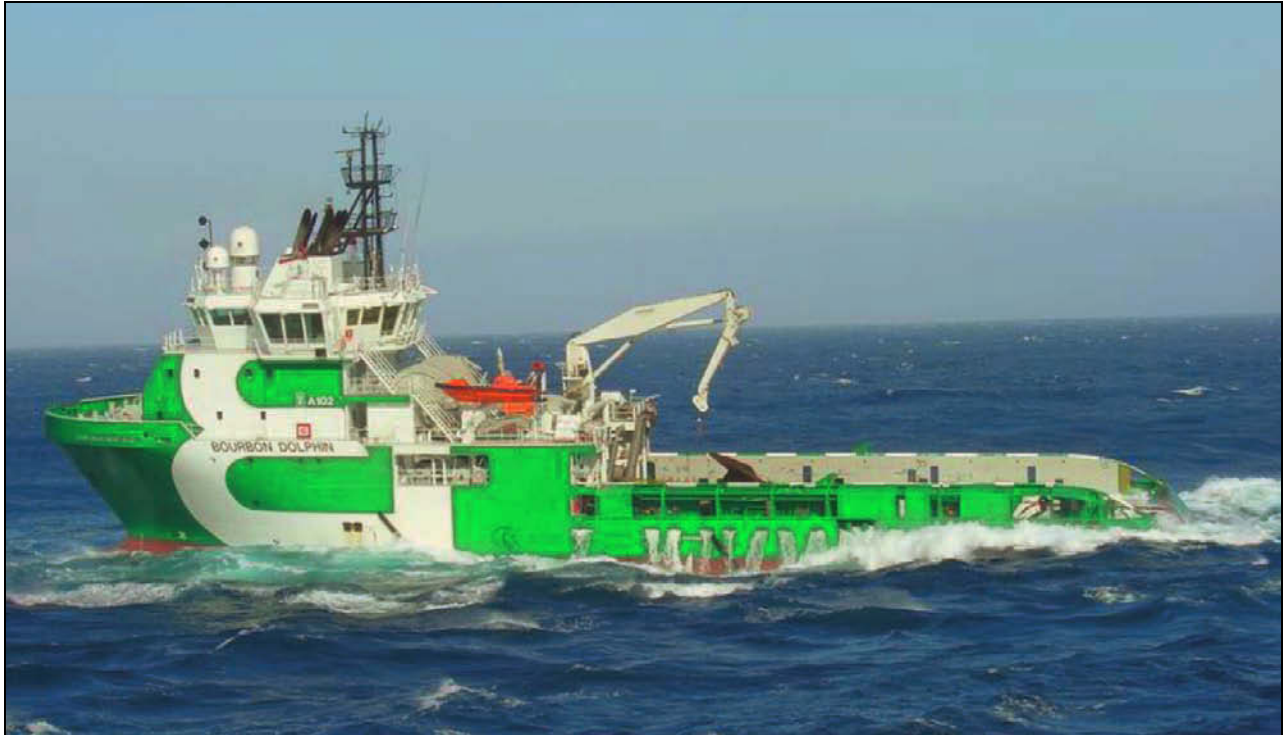
Figure 9.7 Picture taken at 16:02.

The picture in Figure 9.7 indicates that draught is still under 6 m and that the vessel has a slight aft trim. In that all chain in this situation has been run out, it is natural to suppose that the rig chain lockers T18 and T19 have been filled with seawater. This is in line with practice on board, and without ballast in these tanks the vessel's draught would be smaller than the picture indicates.

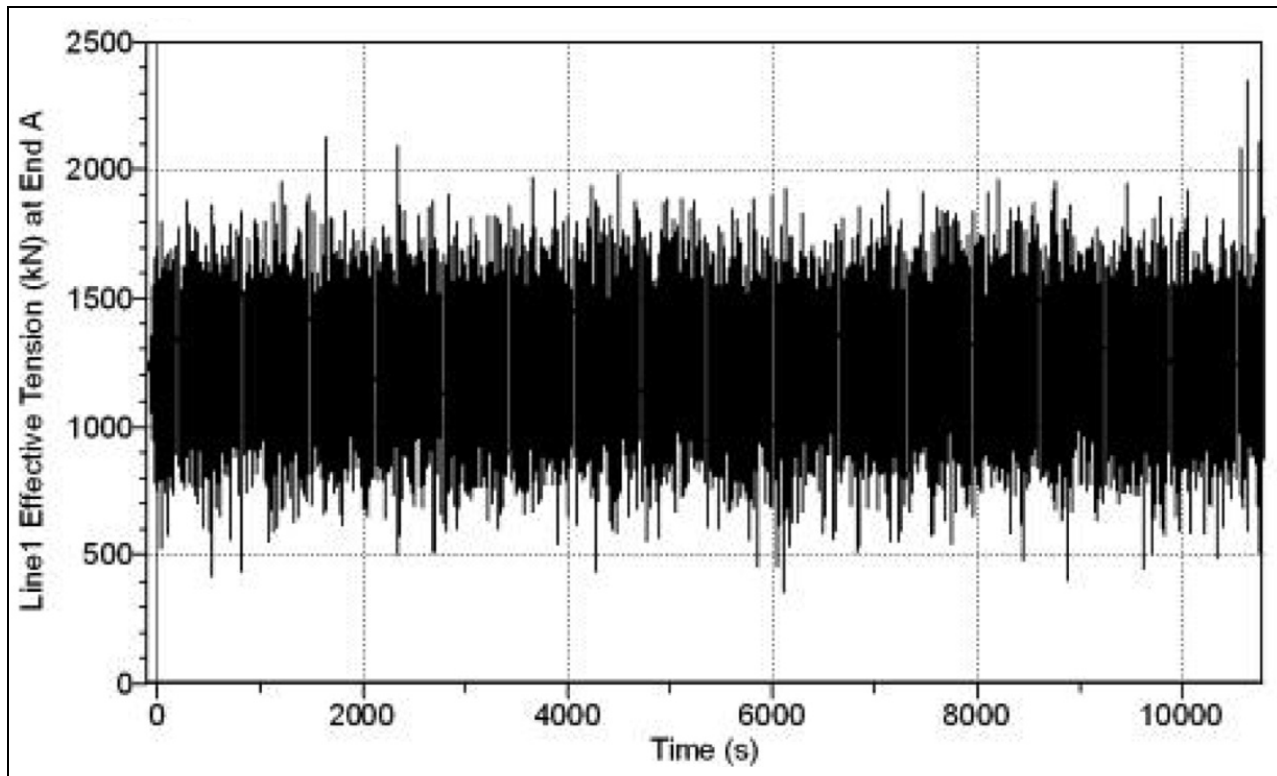
Figure 9.8 Line loads

The analyses show that there is a mean force of 126 tonnes with a standard deviation of 22 tonnes, see Figure 9.8. The vertical component of this force is 100 tonnes and the horizontal component 78 tonnes. The tensions in the simulation vary between 35 and 240 tonnes. As seen in Figure 9.8, the forces vary between 80 and 180 tonnes most of the time. The tension variation has a period corresponding to the waves, confer Section 9.5. This is in conformity with observations made by First Officer Syversen, who stated that he could read tension off the winch as 80 and 180 tonnes during the deployment of anchor no. 2.

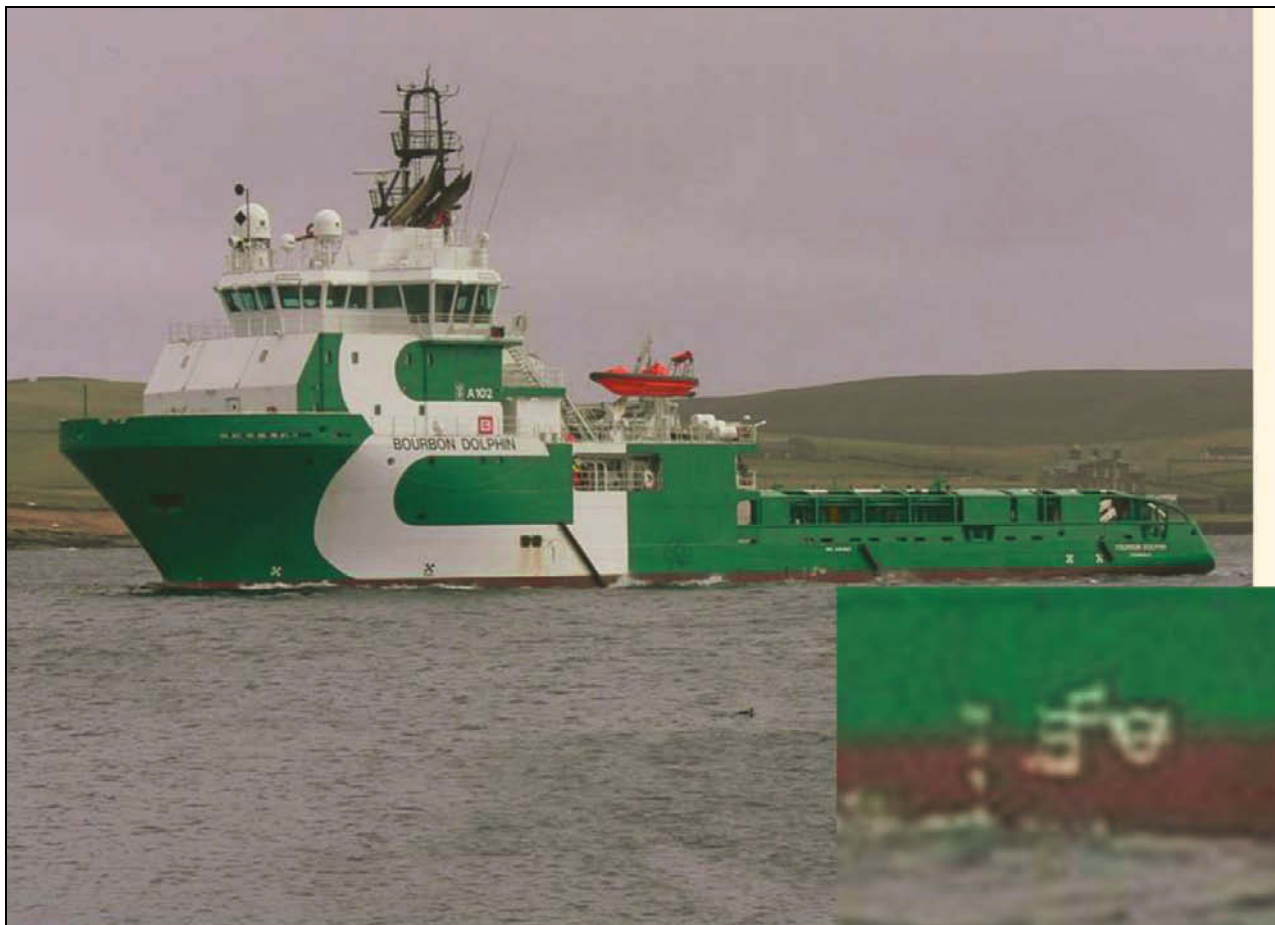
Figure 9.11 Bourbon Dolphin on arrival at Lerwick at 14:35 on 10 April

The vessel was photographed on arrival at Lerwick (see Figure 9.11). From this picture it may

As both Figure 9.11 and the reported draught point in the direction of a mean draught of around 5.8 m, the Commission chooses to use this as a guideline for modelling of the load condition on departure from Lerwick.

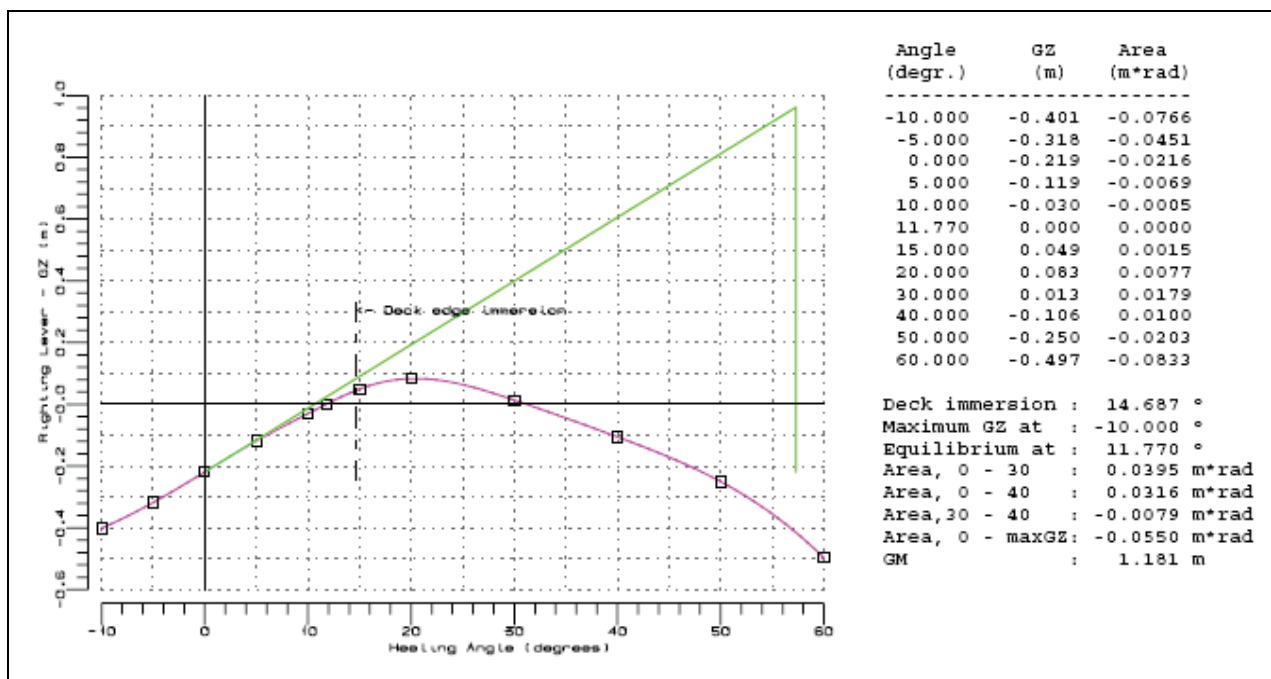
Figure 9.15 Correcting and heeling arms for load condition 3.1 after towing-pin is depressed, 60% angle of attack, 180 tonnes tension

In this situation the vessel has very poor stability. With an angle of attack of 60°, maximum GZ is as low as 0.035 m. In this situation, not much wave effect is needed to capsize the vessel. The GZ curve is shown in Figure 9.15, see also Annex 1, Section 1.12 (pages 16-20) for more details.

Calculations based on 200 tonnes chain tension and an angle of attack of 40° gives a corresponding GZ curve as shown in Figure 9.15.
