Isle of Man Ship Registry

Casualty Investigation Report No. CA118

Isle of Man Registered "Sharp Lady"

Enclosed Space Fatality and Near Fatality

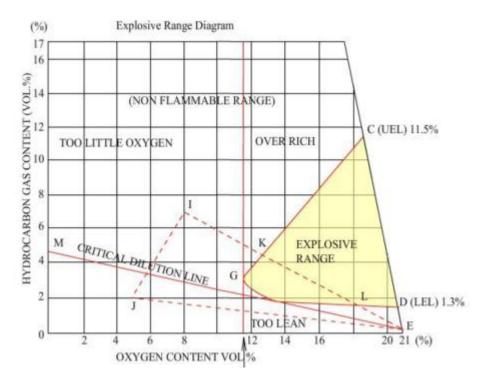
While the Chief Officer had only been in the rank for three months, the Master was very experienced and there would seem to be no reason why the procedure to purge and then gas free was omitted.

There are various references within risk assessments and work permits relating to ensuring the HC level is less than 1% but no description within the Cargo Handling procedures describing the process of purging and gas freeing.
