## Dropped object from crane

Safety Flash Published on 13 February 2020 Generated on 3 July 2025 IMCA SF 05/20

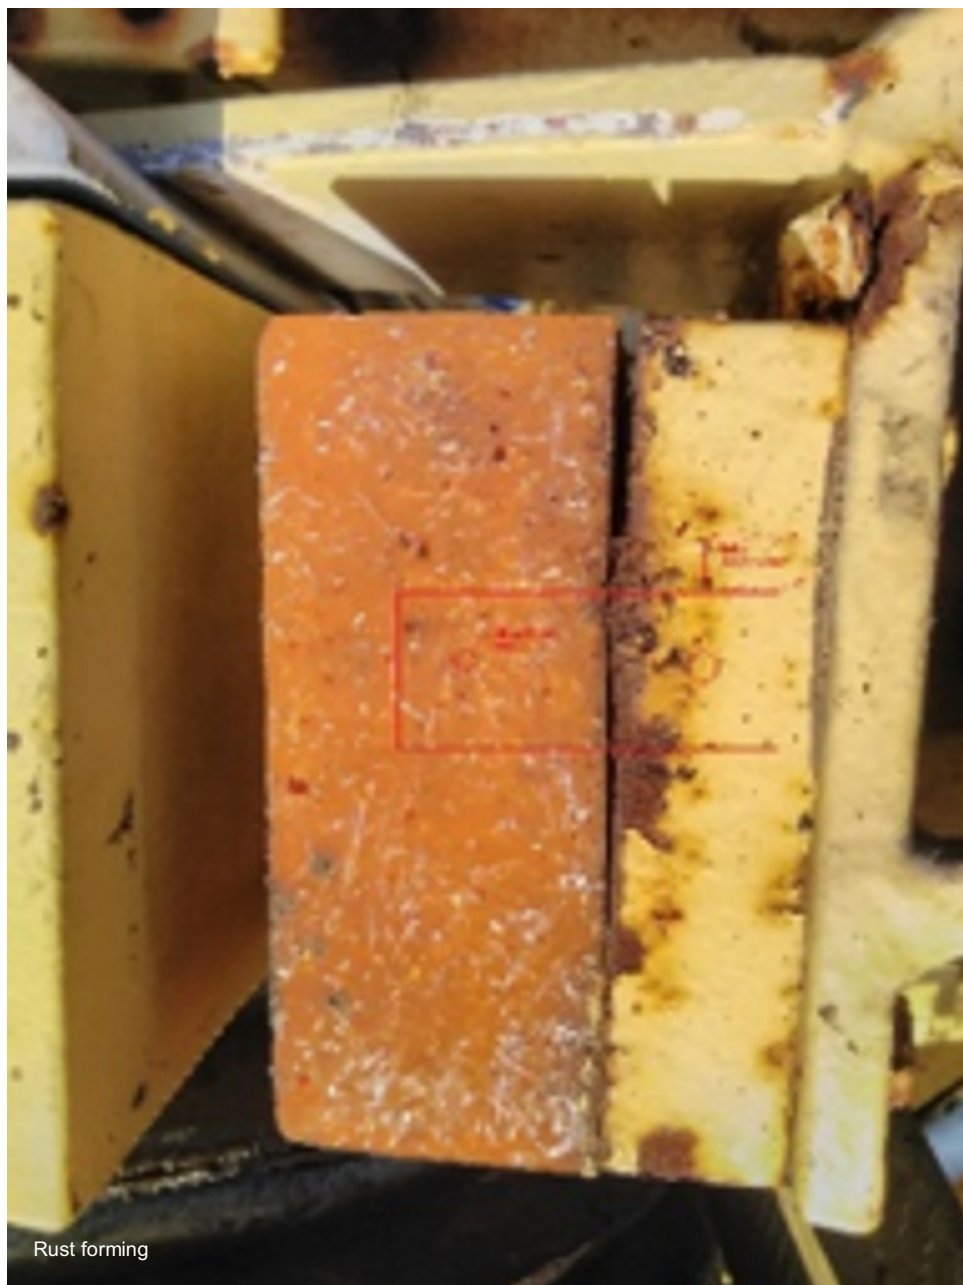
Rust forming

Investigation revealed that the composite block was only glued instead of drilled and fastened to the crane. Rust came in between the steel plate of the crane and the composite block, which loosened it and caused it to fall off.

- Check your own cranes for loose or potentially loose objects and for rust and corrosion and consider engineered solutions to any potential problems identified.
- Consider the area immediately around the crane to be a potential dropped object zone.
- Conduct a fresh dropped object survey on the vessel.
