Equipment damage: Dropped object from tiltable lay system

Safety Flash Published on 20 April 2023 Generated on 19 February 2026 IMCA SF 10/23

A bracket weighing 10.5 kg fell 16 m to deck.

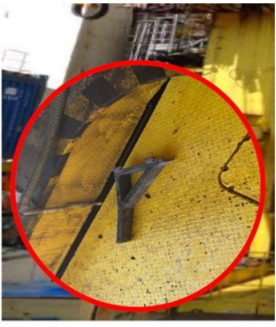
As the tensioner doors were being closed, the port side door made contact with a hinged bracket that was part of an inspection manhole gate which had been left open.

This resulted in the bracket, weighing 10.5 kg, dropping approximately 16 m to the work table below.

Before this event, the inspection manhole gate had been damaged in a previous unreported incident.

Subsequently some minor repair work had been undertaken which involved the removal of the grating from the gate/bracket. The hinged bracket was seized in the upright position and at the time it was not considered a dropped object hazard due to it being firmly secured to the TLS structure.

- The seized bracket was not fully repaired following the original incident.
- The latent hazard posed by seized bracket was not identified as a potential DROPS or as a clashing hazard.

Line of fire

- Although the first incident was recorded within the pipelay team handover notes, there was a failure to formally report it within the company incident reporting system – all damage incidents should be reported to ensure the correct level of investigation, and so that corrective and preventative actions are identified and implemented.
- The equipment design and layout failed to identify the clash points created when manhole gates were left in the open position.
