Dropped object: Lay tower adjuster leg pin

Safety Flash Published on 22 May 2017 Generated on 24 January 2025 IMCA SF 11/17

The securing pin from a tiltable lay system (TLS) adjuster leg, weighing 600 kg, fell 16 m to deck.

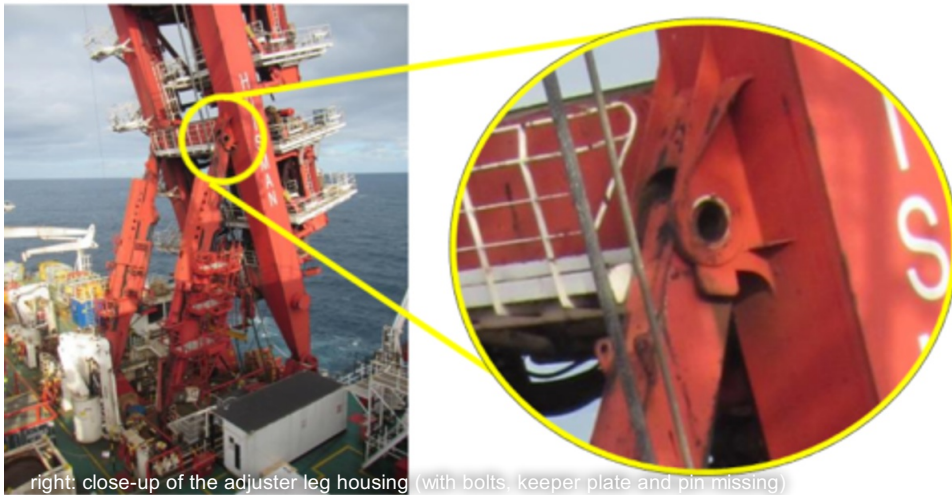
The incident occurred when the keeper plate bolts slackened off. No-one was in the immediate area below the adjuster leg at the time of the event and no-one was injured.

right: close-up of the adjuster leg housing (with bolts, keeper plate and pin missing)

- Investigations found that the planned maintenance and inspection regime was inadequate and unclear.
- During transits the tower was at times kept in operational position which could have allowed excess movement of the pin due to reduced load and increased dynamic movement.
- The design made it difficult to lubricate the pin adequately which may have caused excess friction.

- Following discussions with the manufacturer, the vessel returned to port for investigation, and during the transit to port, Structural Non-Destructive Testing (NDT) of pin connecting parts was undertaken on both legs to verify sufficient load capacity and seaworthiness.
- Adjuster leg pin put back in place and increased diameter anti-rotation locking key bolts were installed to provide additional bolt shear strength, as per manufacturers recommendation.
- Additional temporary bolt locking mechanisms (Loctite and locking wires) were installed on both adjuster leg pins locking key bolts to ensure vibration would not loosen the bolts before the permanent solution was ready.
- A check was made throughout the tower, of the tightness of all critical bolts and pins; new pin, bushing and lubricating lines were installed.

- Tower to be in survival mode position during all transits according to the manufacturer's recommendations.
- Planned maintenance requirements updated and clearly defined for accurate inspection criteria for critical pins and securing mechanisms.
- Bolt locking mechanisms installed in TLS critical pins (adjusters and TLS pivot) to ensure vibration will not loosen critical bolts.
