LTI – Struck when anchor wire end pulled free of drum clamps

Safety Flash Published on 4 July 2022 Generated on 23 January 2025 IMCA SF 16/22

A person was seriously injured when he was struck by the end of a 58mm anchor wire.

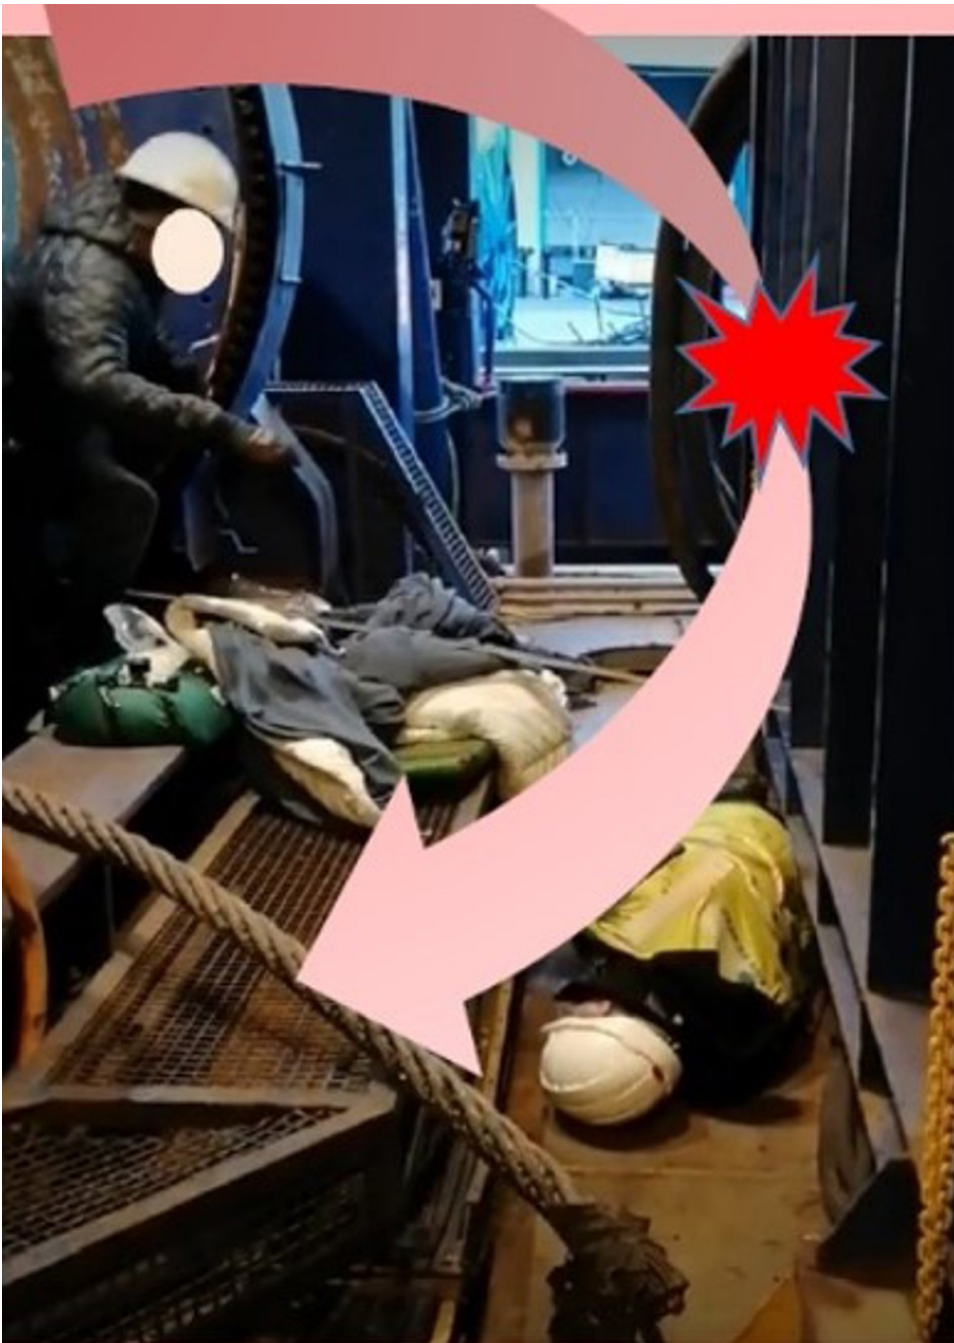
The incident occurred when crew were working on replacing out several 58mm anchor wires. The injured person was walking behind an anchor winch which had a single turn of wire remaining on it. The vessel moved off the quay. Tension came on the wire, which was connected to a spooler ashore. The stoppers in use failed, and the wire end pulled free of the already loosened clamps, whipping over the drum. He was struck across the shoulders/lower neck and suffered several skull fractures when he was pushed into an adjacent bulkhead by the impact, before falling to the deck semi-conscious.

- A generic 'mooring operations' risk assessment was being used. Toolbox Talks had been conducted and documented, but these were based around a clearly inadequate risk assessment (and nobody questioned it during the TBT).
- The stopper arrangement was inadequate. Wires must only ever be stoppered to a suitable strong point using chain stoppers, as detailed in the [Code of safe working practices for merchant seafarers \(COSWP\) 2021](#).
- Safety chains had not been deployed behind the winch. At that stage of the operation, there was a 'Line of Fire' hazard (an alternative route would only have taken about twenty seconds more).
- Insufficient attention was being paid to the tension on the wire by the spooler operators.
- Perceived time pressures and fatigue may also have been factors.

- More thorough planning and more thorough risk assessment would have eliminated most of the several factors which contributed to this incident.
- Adequate time and resources should be allowed in operational plans to allow for effective risk assessment; both vessel crew, project crew and shore-based management have responsibilities in this respect.
