Fall from height – LTI

Safety Flash Published on 13 July 2017 Generated on 28 January 2026 IMCA SF 17/17

A supervisor fell through an upper deck hatch on a vessel alongside, suffering injuries that required surgery and physiotherapy and several months away from work.

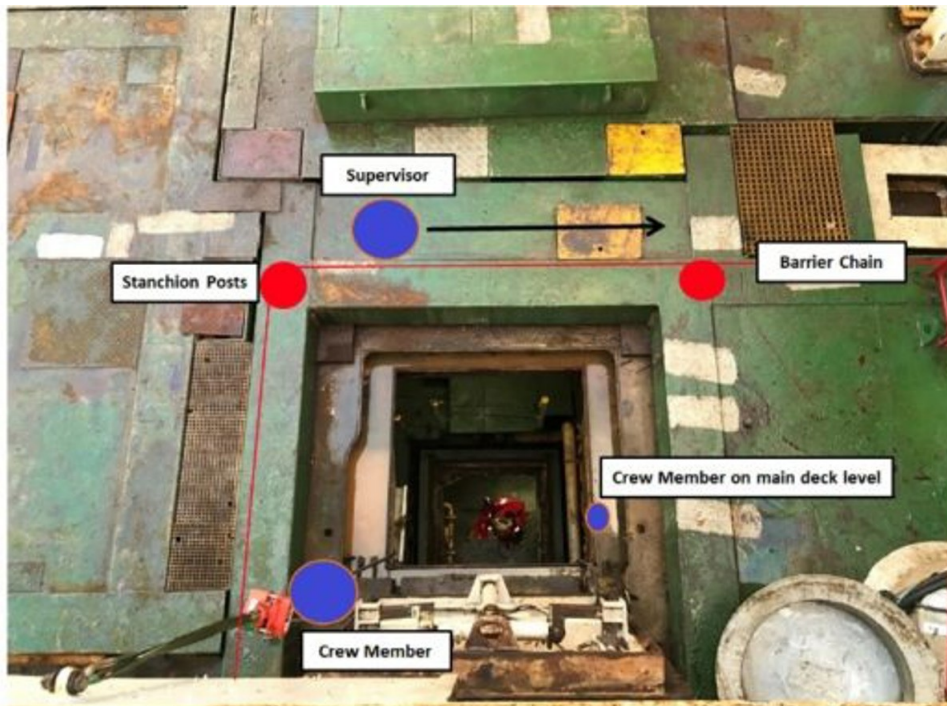
A portable barrier (two stanchions and length of chain) was put around the area to warn of a trip hazard. This was because although it was closed, the hatch was not fully sea-fastened.

Crew operating the chain pulls were stood inside the barriered off area, wearing fall arrest harness and inertia reel. Their supervisor was on the upper main deck outside of the barriered off area. As the equipment was being lifted using this technique, he moved to get a better look at what was happening. As he did so, he lost his footing and tipped forward toward the portable barrier stanchions and chain, and fell through the barrier and down the hatch.

- Fall prevention barriers that were around the upper main deck hatch were not suitable or sufficient. There was insufficient robust barrier hardware available on board.
- Several trip hazards existed around the area:
 - where the task was being carried out

- where the supervisor was standing
- where the portable barrier was previously positioned – this was also close to the edge of the open upper main deck hatch.
- The supervisor was too close to open hatch hazards without sufficient fall protection.
- Visual obstruction prompted the supervisor to move to get a better look at the activities he was supervising. In so doing he knocked against the portable barrier.
- The supervisor lost his footing/balance close to the edge of the portable barrier and open deck hatches.
- A generic or blanket Permit to Work was used for the recovery/lifting of this equipment using a working at height/chain pull method, rather than a specific Permit to Work.

- Time spent discussing the lift in detail, may have detracted from proper review of the suitability of the existing barrier, and possibly divided attention over risks from the lift versus that from the fall.
- Better management required of Permit to Work system for specific and non-routine tasks.
- A proper review of the barrier previously put in place, and its adequacy to protect against falls versus highlighting a potential trip hazard, seems to have been forgotten during the planning stages of the task.
- Lapses do happen – Comprehensive checklists to confirm specific actions required can help address potential lapses. These checklists could be included in pre-task dynamic/situational assessment, and standard pre-start checks made within the Permit to Work process.
