LTI: Three fingers badly cut while handling a long brass bar

Safety Flash Published on 1 October 2021 Generated on 23 January 2025 IMCA SF 27/21

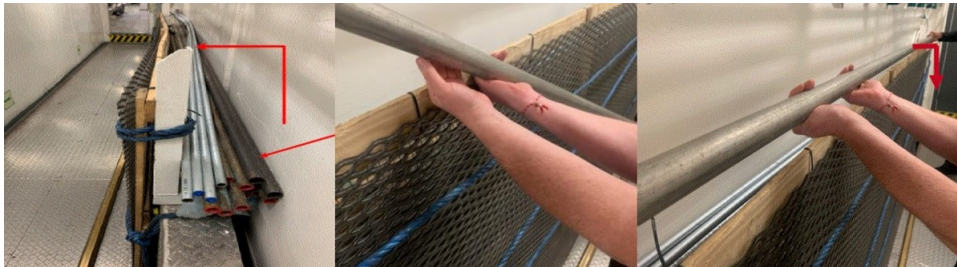
The brass bar was lying behind a wooden frame and behind two pieces of expanded metal mesh sheets.

Working alone, the injured person lifted the bar in stages to remove it from its storage. He first lifted the forward end of the bar which suddenly slipped, forcing his left hand downwards and against sharp edges on the steel wire mesh which, ripping into the skin under the weight of the bar, caused the injury.
