Low pressure mud hose parted

Safety Flash Published on 19 April 2011 Generated on 28 January 2026 IMCA SF 04/11

A Member has reported an incident in which a low pressure mud hose parted.

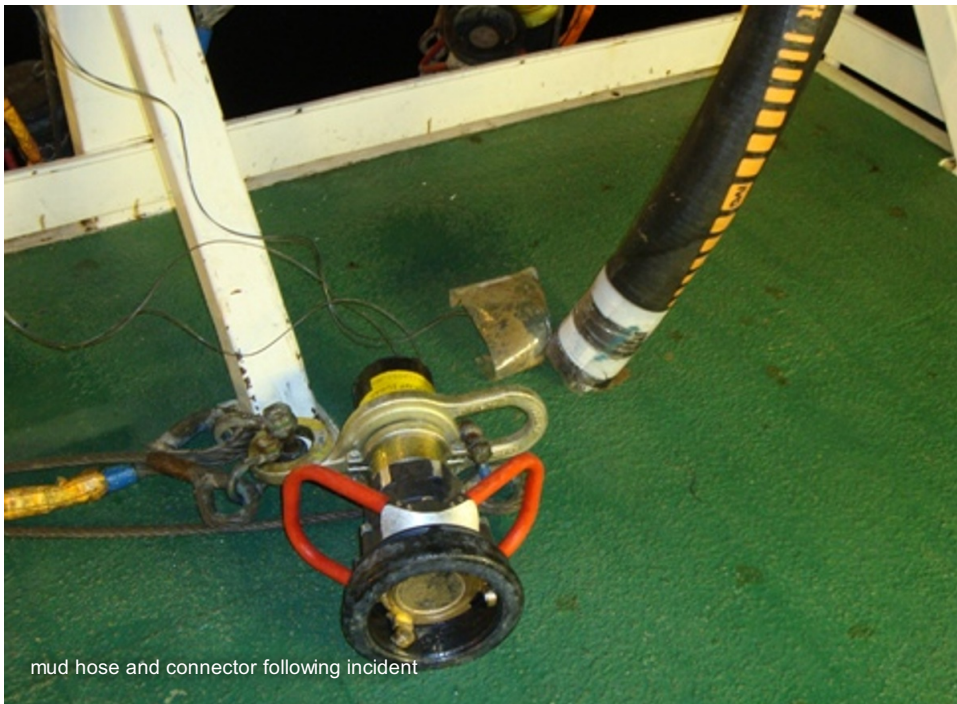
The mud hose was disconnected from the vessel manifold, and the vessel banksman gave a signal to the crane operator to lower the sling. The hose was attached to the sling and a signal was given to raise the hose. The intent was that the crane should take the weight of the hose and then the securing line from the vessel to the hose could be more easily disconnected. However, the crane operator misunderstood the hand signals and continued to lift whilst the hose was still lashed to the vessel. As a result the coupling and hose parted.

As transfer of mud had stopped, there was no spill and there were no injuries.

- Procedures not understood.

- The crane operator may not have been aware that the hose was lashed to the vessel.
- There was poor visibility at the time of the incident owing to heavy rain.

- Communication between work groups was not effective . poor visibility noted at the time of the incident, and the crane driver may not have seen the stop sign by the banksman.
- The banksman did not have direct very high frequency (VHF) communication with the crane operator.

- There should be clear and continuous radio communication between vessel master and the crane operator and banksman during lifting operations.
- Hand signals can be used provided the banksman can always be clearly seen by the crane operator. In conditions of poor visibility, radio communication between banksman and crane operator should be clear and continuous.
