## Near miss: Potential fire – overheating of oil in deep frying pan

Safety Flash Published on 12 March 2019 Generated on 28 January 2026 IMCA SF 04/19

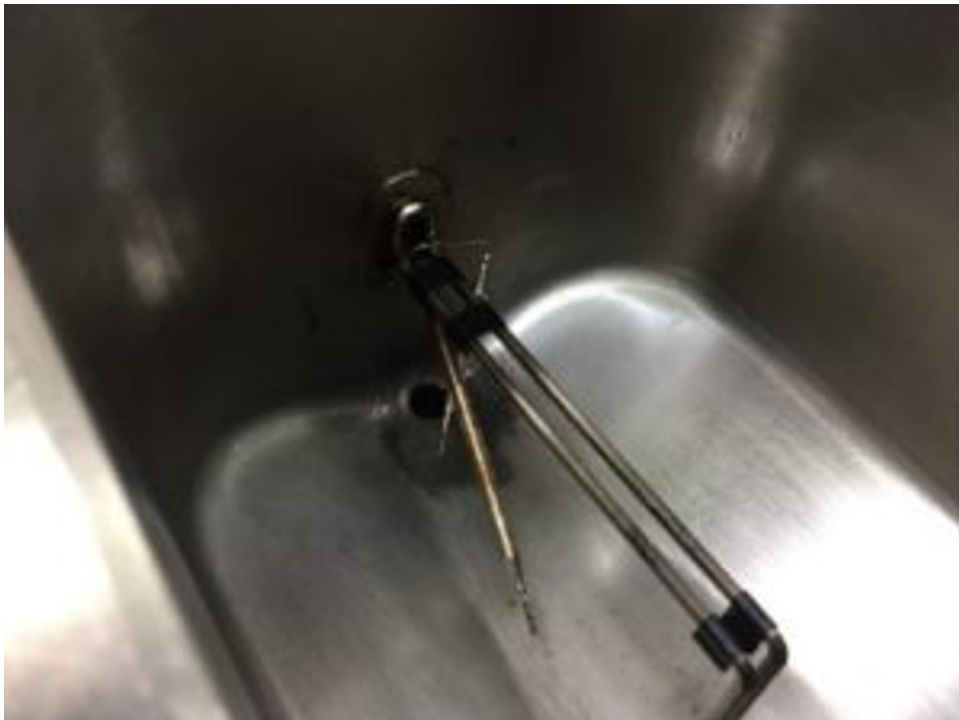
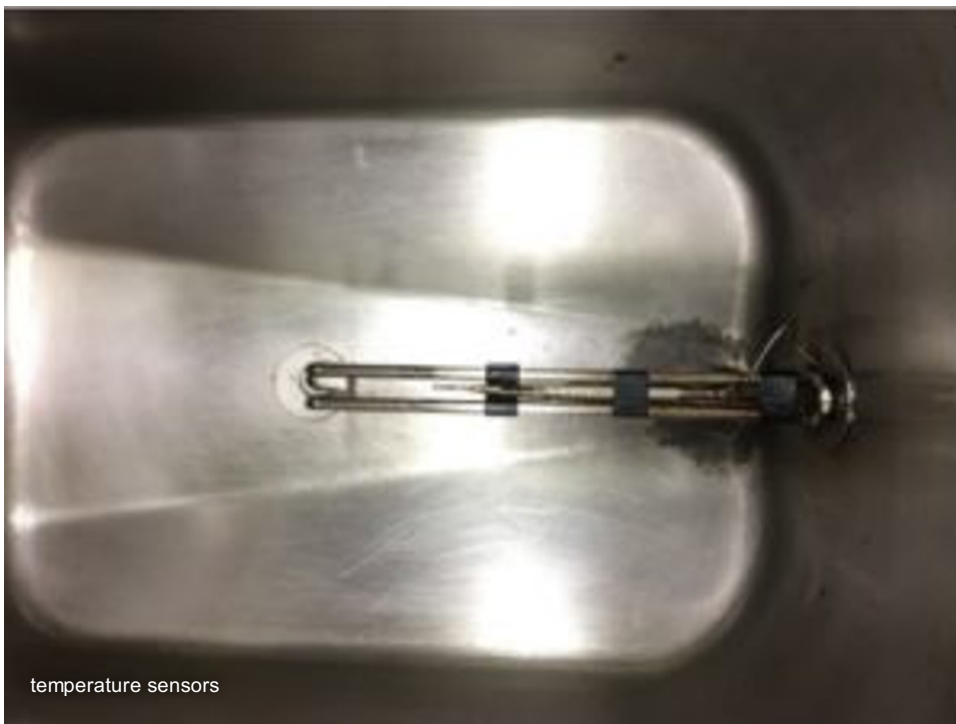
The deep-frying pan was switched off and a lock out/tag out was applied for further investigation. The frying pan was allowed to cool down and the oil drained out. When the oil from the deep-frying pan was cooled down and drained it was noticed that the temperature sensor elements of both thermostats were not in the original place.

temperature sensors

- Temperature sensor elements of both thermostats were not fitted in the original place.
- The galley crew were not aware of the function of the temperature sensor elements inside the deep-fryer, nor of the potential consequences if those sensor elements were in the wrong place.

- Clear instructions provided for galley crew about the cleaning of a deep-frying pan, including ensuring that the galley crew are aware of proper positioning of the temperature sensors inside the deep-frying pan during the cleaning process, and know not to move them.
- Recommend check of positioning of temperature sensors on similar equipment in galleys on other vessels.
- On this specific vessel, replace thermostat sensors in the original position and check thermostats with a calibrated temperature probe.
