# Near-miss: Strong sun glare contributes to heavy impact on boat landing

Safety Flash Published on 16 April 2014 Generated on 16 January 2025 IMCA SF 06/14

A member reported an incident in which a CTV (crew transfer vessel) made a heavy impact on a boat landing on an offshore renewable energy turbine tower.

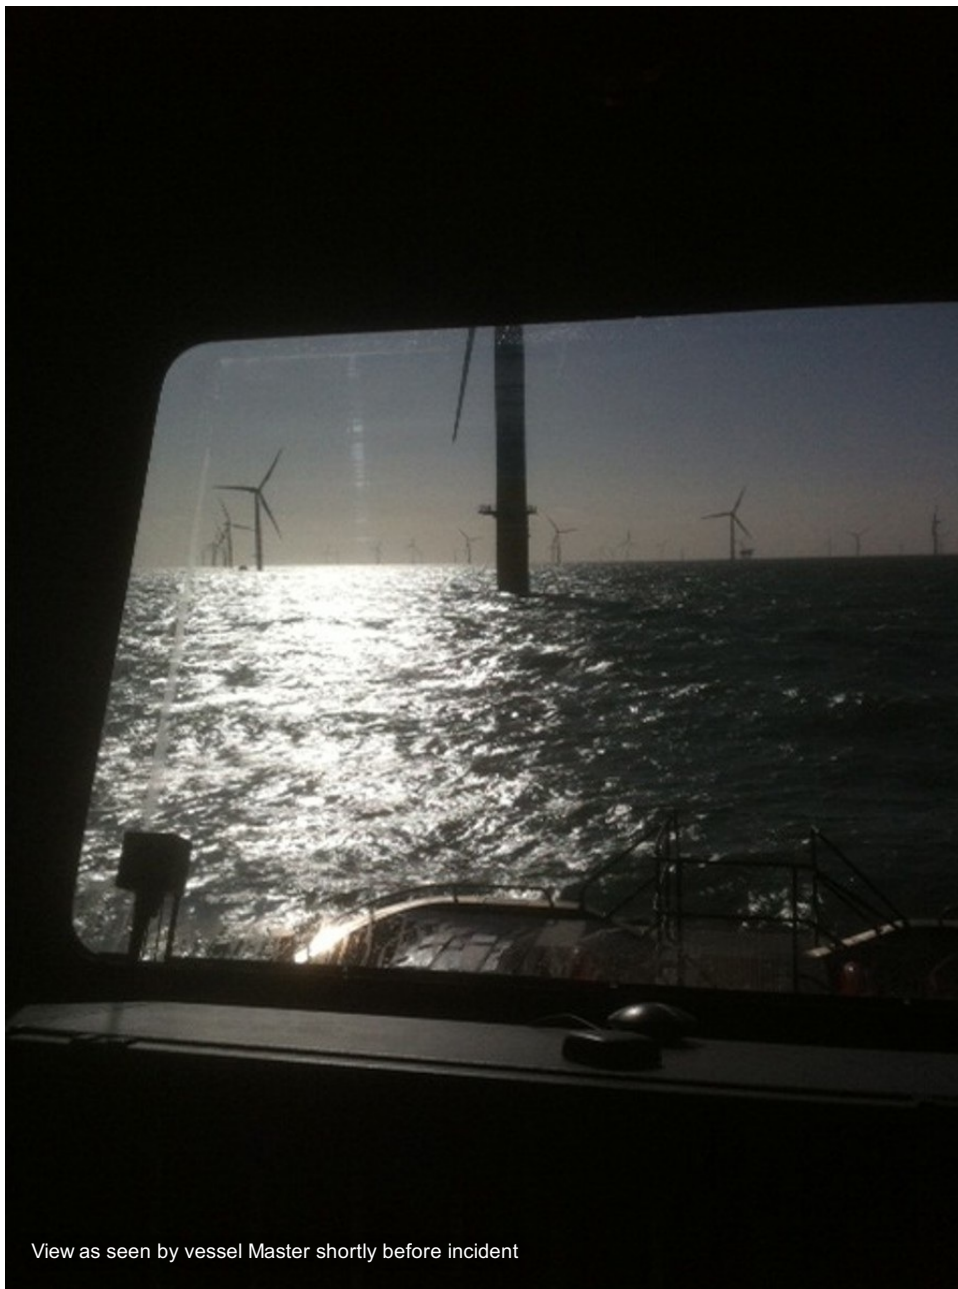
The weather conditions were 1-1.5m significant wave height, wind on the beam of the vessel and a flood tide. On this occasion the sun was low in the sky almost directly behind the turbine tower and was causing significant glare on the water. Although sunshades were in place and adjusted, the Master found it difficult to judge the final approach and landed on the boat landing in excess of the threshold limit of 200 KN. There was no damage to the vessel or injury to crew.

View as seen by vessel Master shortly before incident

- The heavy impact was recorded by the 'vessel black box' monitoring equipment.
- Whilst the conditions made manoeuvring the CTV challenging, more than 30 landings had already been made without incident.
- The glare made it difficult to judge the distance in final approach.
- The approach could have been delayed to allow for the glare to reduce.

- Revision of generic risk assessment for navigation along with procedures for small vessel operations.
- Reminded vessel Masters to take into account all elements of visibility and to adjust their passage plans and approaches accordingly, including

delaying a pickup, if they deem that the conditions are not safe.
