Fatal electrocution

Safety Flash Published on 2 June 2009 Generated on 14 January 2025 IMCA SF 07/09

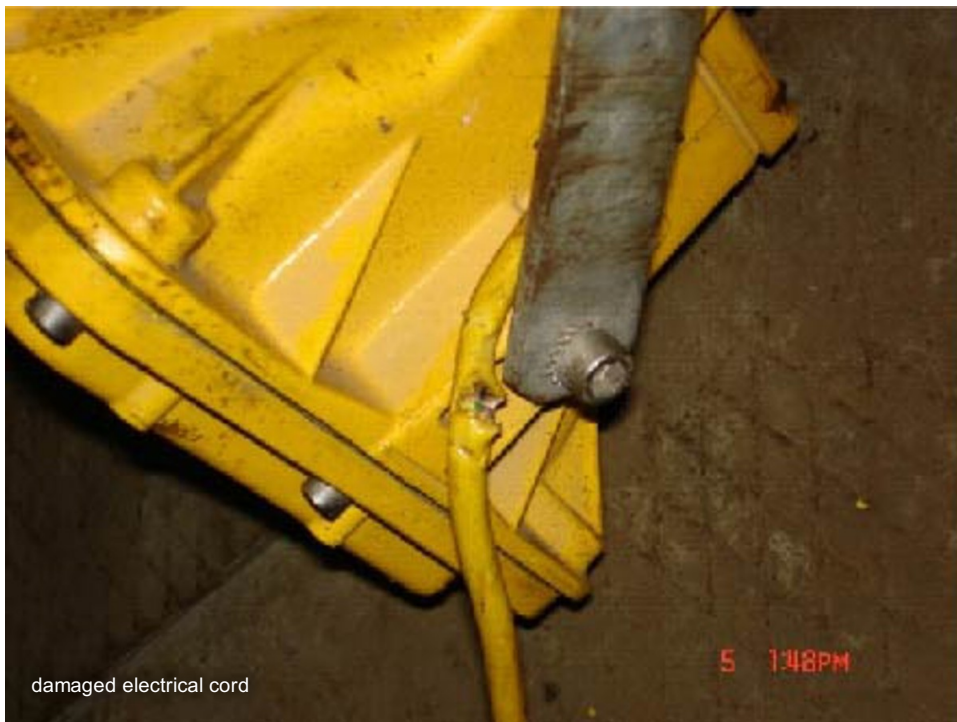
A rig sub-contractor suffered fatal injuries from electrical shock whilst performing a welding operation. A lamp used to illuminate the worksite was found to be a potential source of electrical shock as the lamp's electrical cord was found to have been damaged.

The damage may have been caused by a pinching action of the cord between the loose mounting bracket of the light and the light housing which was observed to be in contact with the victim's body.

- When using portable electric tools in potentially damp areas, a GFCI (fixed or portable) should be utilised to protect personnel from potential electrical shock.

- All tools and equipment should only be used for their intended and manufacturer's recommended purpose; any change to a tool or equipment's intended purpose should be thoroughly reviewed and approved through an effective management of change (MoC) process.
