Near-miss: Laundry fire hazards

Safety Flash Published on 31 March 2016 Generated on 16 January 2025 IMCA SF 07/16

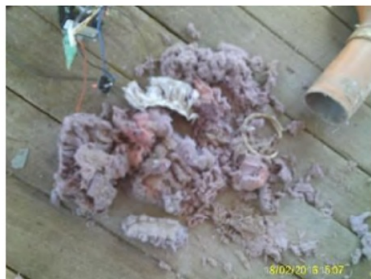
A member has reported a near miss which might have developed into a fire in the laundry room. During a weekly inspection of the laundry room, rags and lint twisted together were discovered in the dryer exhaust fan. Further investigation revealed more accumulated lint within the dryer's outlet exhaust pipe. When the end of the outlet pipe was removed to check the inside, it was found that it was approximately 85% blocked by lint.

- Although the dryer's lint filter was in place at the time, the evidence clearly indicates that it hadn't always been in use, or had been used incorrectly – the correct use and installation, and frequent checking of, lint filters is essential to avoid such potentially hazardous situations.
- Use of ventilation pipes and systems can create traps in which lint accumulates over a period of time, especially if lint traps are not in use or defective – this creates a fire hazard. Such venting systems should be regularly checked to ensure that they are free of obstructions.
- There was no management of change (MoC), risk assessment or forward planning conducted to fully assess the impact of fitting the venting pipe.

- Immediately removed the outlet exhaust pipe for thorough cleaning and removal of lint.
- Subsequently, the dryers were relocated to an external area (winch housing) where they could vent directly to atmosphere.
