## High potential dropped objects from wind turbine Nacelle crane

Safety Flash Published on 26 February 2020 Generated on 21 January 2025 IMCA SF 07/20

**Two lifting bags detached and fell from the crane hook on a wind turbine tower**

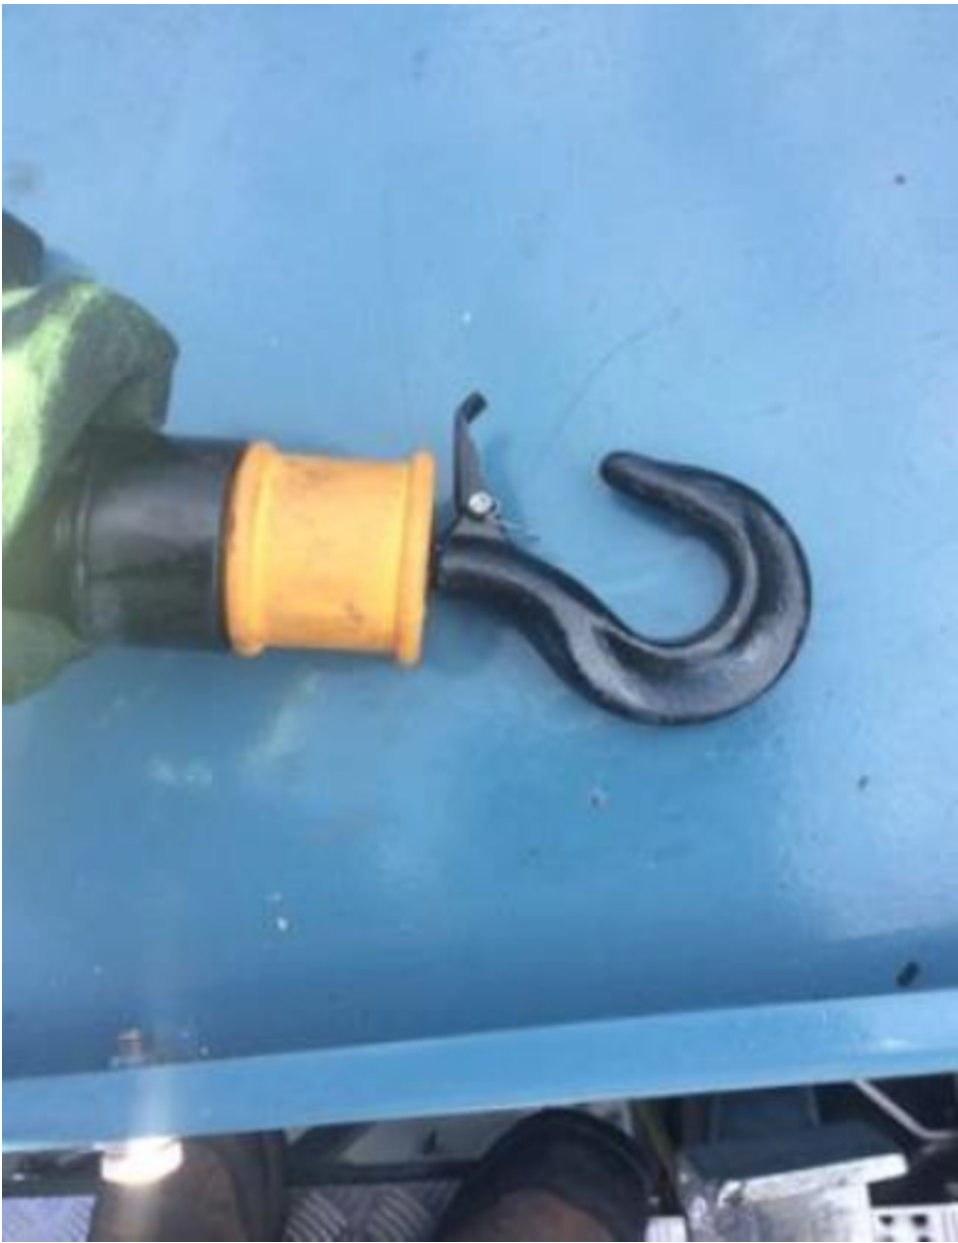
The safety latch on the lifting hook had suffered damage and failed.

The investigation noted that this potentially indicated that the hook was incorrectly loaded, which had resulted in excess pressure on the safety latch of the crane hook causing it to become defective.

- Ensure any planned lifting operations are verified to ensure safe loading techniques are employed.
- A toolbox talk (TBT) to be delivered to all service technicians as a reminder of the correct procedure for rigging the nacelle crane and dangers of incorrect loading.
