Loss of heading control on an FPU during diving operations

Safety Flash Published on 27 March 2024 Generated on 28 January 2026 IMCA SF 07/24

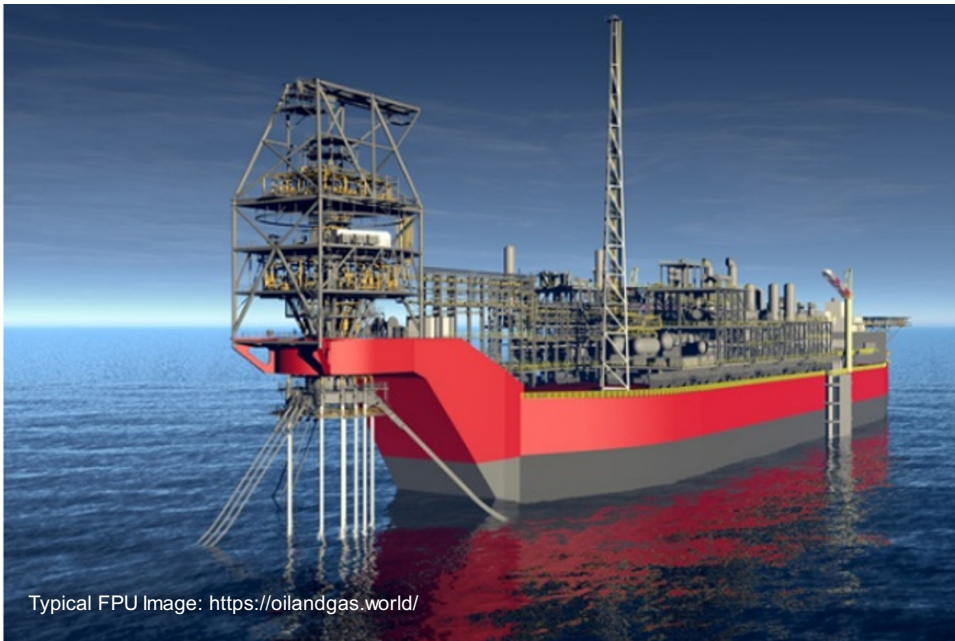
Photo

Typical FPU Image: <https://oilandgas.world/>
