## Lacerated chin caused by flying wedge

Safety Flash Published on 15 December 2010 Generated on 28 January 2026 IMCA SF 08/10

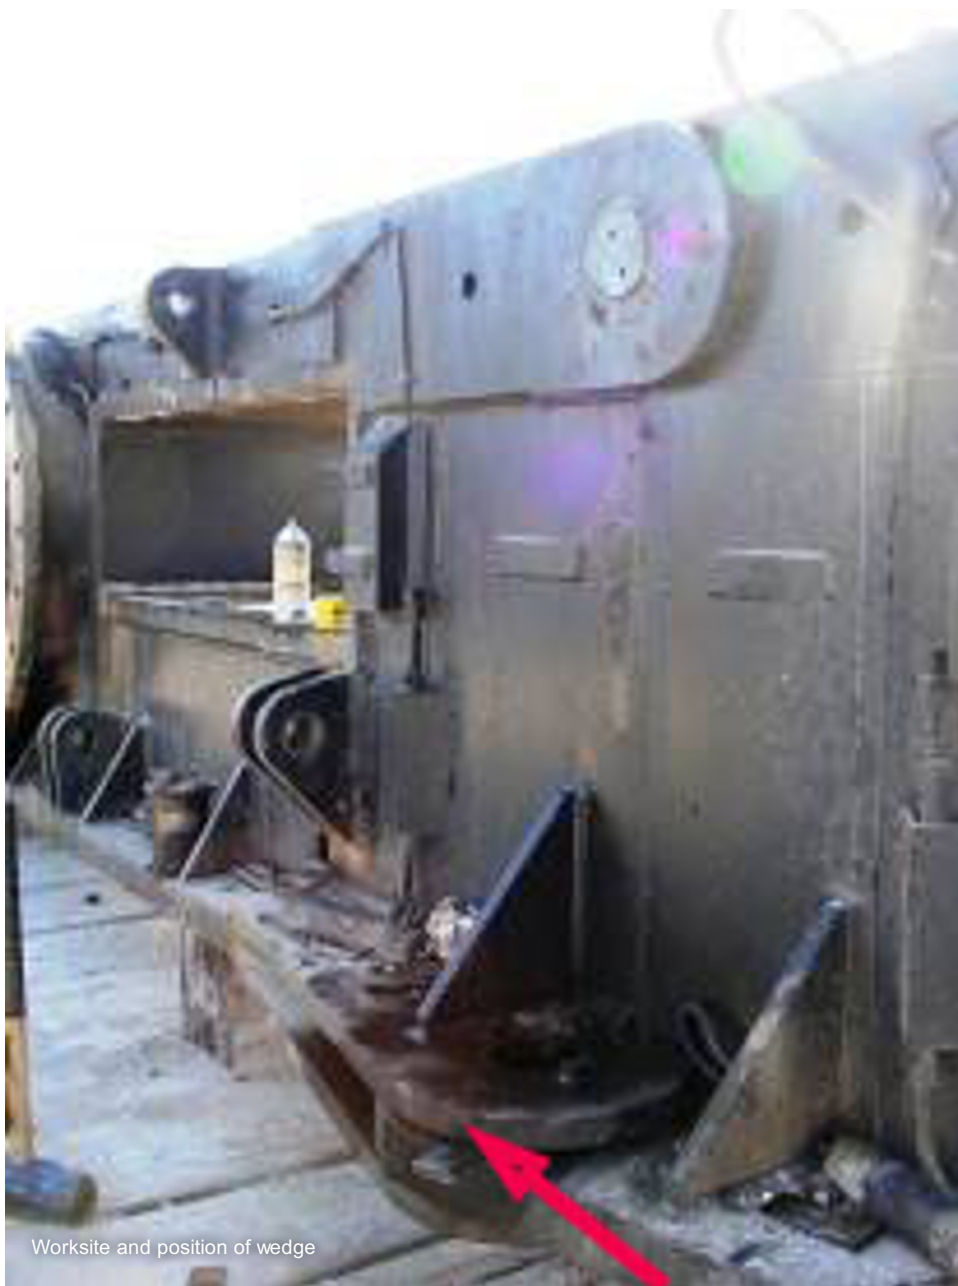
A worker was removing a steel wedge from the frame of a crane track during disassembly. The wedge dislodged when struck by a sledge hammer and ricocheted against the frame before striking the worker. The worker was taken to an offsite facility for treatment where he received stitches. He was able to return to work without restrictions.

- The wedge was in a bind when it was struck.
- The injured person was 'in line of fire' for the rebound of the wedge after it was struck by the sledge hammer.
- The injured person was not wearing a face shield whilst removing the wedge.
- Established procedures did not adequately recognise or cover the hazards for the task being performed.

Worksite and position of wedge

- The use of wedges for this process should be eliminated and the appropriate alternative tools used for pin alignment and removal.
- Appropriate personal protective equipment (PPE) including face shields should be used for required wedge hammering, impacting and banding operations.
- More detailed work plans were developed down to the task level, including specific PPE for each task, appropriate tools and body positioning.
