Fire caused by hot work

Safety Flash Published on 21 May 2013 Generated on 12 January 2025 IMCA SF 08/13

A Member has reported an incident in which a small fire was caused by hot work taking place on the deck above.

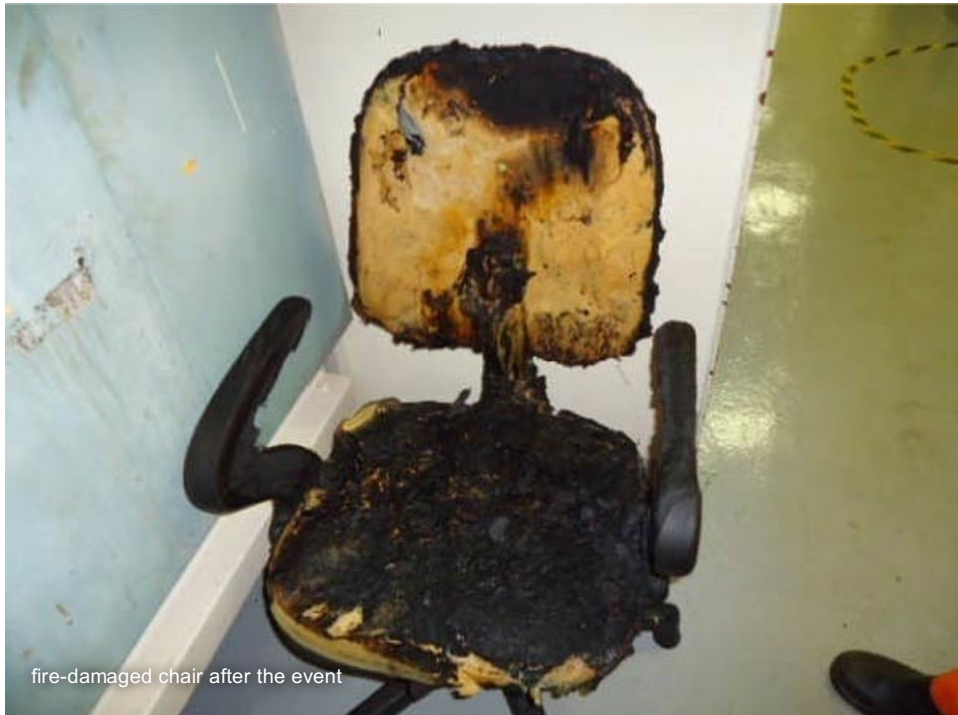
During this activity, the oxy-acetylene cutting of the plate caused heat transfer from the forecastle deck area to the store-man's office area (located directly below the place where the hot work was being carried out). As a result, glowing slag fell on the store-man's chair, which caught fire.

There was no-one in the storeman's office at the time. The fire detection equipment in the office caused the alarm to go off. There were no injuries.

- **Immediate causes:**
 - Fire watch location was not well planned by supervision.
 - Melt slag fell on top of the store-man's chair.

- Failure to control and conduct safe work (permit to work planning failed).
- Failed check of the workplace.
- Inadequate risk assessment (warning about the smell of smoke in the storeman's office was not investigated by the fire watcher).

- Held discussion with all parties involved to ensure all understand their responsibilities.
- Ensured that any spaces identified as at risk of heat transfer from hot work are identified in the appropriate section of the job risk analysis beforehand.
- Raised awareness of correct identification of adjoining compartments/spaces in regard to hot work and heat transfer through bulkheads, decks, etc.

- Double check (second pair of eyes) to identify any deck penetrations to improve spatial awareness.
- Ensure fire detection system is fully functional during hot work.
