## MSF: Air cylinder failure in lifeboat

Safety Flash Published on 17 March 2021 Generated on 23 January 2025 IMCA SF 08/21

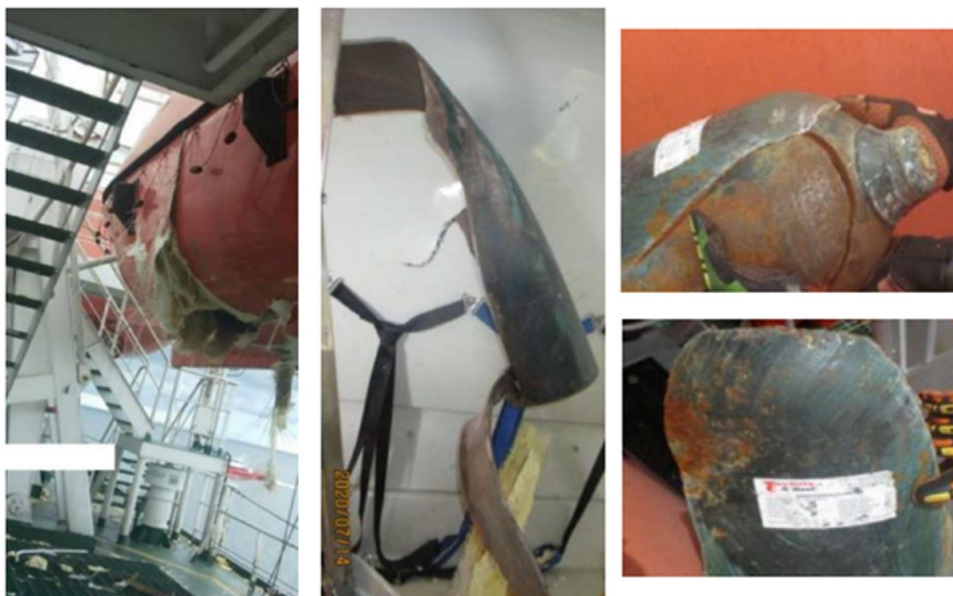
There was a structural failure of an air cylinder fitted in a lifeboat. It occurred without warning. No work had or was being conducted on or around the air cylinder. Three crew members working nearby were injured by the blast debris.

Two preliminary suspected causes of the cylinder failure have been identified:

1. Galvanic corrosion between the cylinder material and the metal support frame leading to a weakness in the cylinder wall.
2. Cylinders submerged in bilge water for extended period leading to wall corrosion which could have then affected the integrity.

The MSF's correspondent recommends that such cylinders are:

- Inspected annually for corrosion or wall damage by service providers.
- Hydrostatic [pressure] tested at a required interval of five years.
