## Lost time injury (LTI): Serious hand injury – caught in the bight

Safety Flash Published on 16 June 2014 Generated on 21 January 2025 IMCA SF 09/14

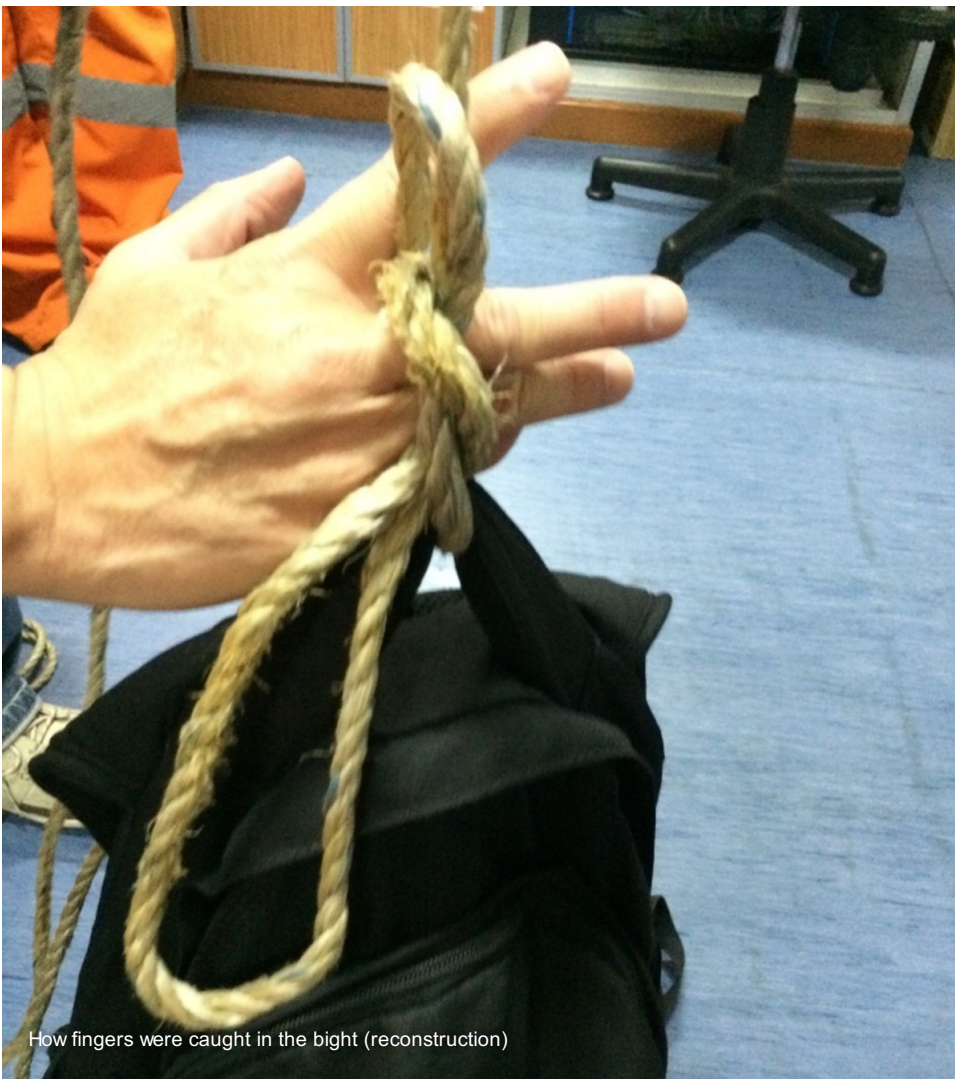
As the injured party was untying the line, the vessel took a sudden dip due to the high swells. He could not retract his left hand fast enough and three of his fingers were caught in the bight of the knot when the heaving line suddenly tensioned. The injured person pushed against the stern deck railing to prevent being pulled overboard. Subsequently the heaving line severed his little finger and lacerated the ring and middle fingers. The rope was finally cut and removed from his finger after crew fetched a knife from the accommodation.

How fingers were caught in the bight (reconstruction)

- This was the first time this method of baggage transfer had been used by any of the crew. It was initiated on the spur of the moment, without any thought, risk assessment or planning – there was no Management of Change.
- The rope was secured to the platform in such a way that it could not easily be released or slackened.
- The platform crew were inexperienced at tying appropriate knots and tied excessive knots in the small diameter polypropylene rope which were difficult and time consuming to untie.
- To speed up the transfer process two bags were lowered on each end of the secured heaving line, dividing the attention of the deck crew.

- Always ensure operational risks are identified and assessed prior to starting operations.
- Don't be tolerant of unacceptable risk.
- Always be mindful of the impact of changing customary methods of 'routine' operations.
- Always ensure operations are well planned, communicated and supervised.
