Machinery damaged through improper maintenance technique

Safety Flash Published on 28 May 2026 Generated on 28 May 2026 IMCA SF 10/26

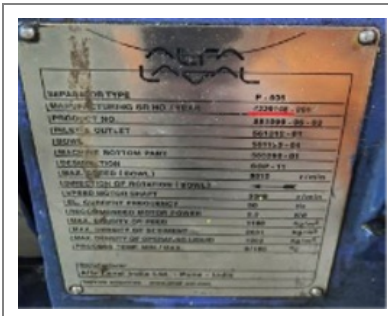
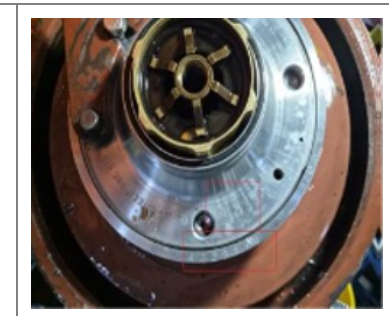
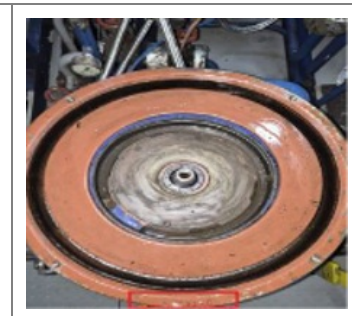
Further investigation revealed that purifier bowl components had been swapped with parts from the lube oil purifier, with different serial numbers. After reinstalling genuine parts, the purifier showed excessive current flow and high vibration. Inspection confirmed mechanical damage to the bowl caused by improper dismantling.

<p><i>Purifier nameplate, serial number ending ----148</i></p>	<p><i>Bowl component parts, s/n ending ---147</i></p>	<p><i>Purifier body, s/n ending -- -148</i></p>

- The procedures provided by the Original Equipment Manufacturer (OEM) were not followed.
 - Special tools specified by the OEM were not used, causing mechanical damage to critical parts. The purifier bowl and related components were dismantled without using special tools specified in the OEM manual.
- Compatibility of parts was not verified before installation. Parts were interchanged that should not have been interchanged. Parts with serial number linkage (bowl, sliding piston, cover etc.) were not freely interchangeable;
- Existing planned maintenance intervals were not followed.
- Maintenance documentation and traceability was found to be inadequate.

- Always follow the OEM manual and use specified tools for disassembly, assembly and maintenance.
- Carefully and thoroughly verify that you have the correct, compatible and genuine parts – in this case, using parts from another purifier may have led to excessive vibration/high current which may have damaged the whole machine.
- Communication and documentation: Keep detailed records with supporting documents of repairs and overhauls, with, where applicable, specific running hours and the condition of the unit.
- Use Stop Work Authority!
