Parting of slings causing fall of heavy object onto seabed

Safety Flash Published on 18 September 2006 Generated on 14 January 2025 IMCA SF 11/06

A diving support vessel was installing a 24 tonne metallic cover onto a subsea valve.

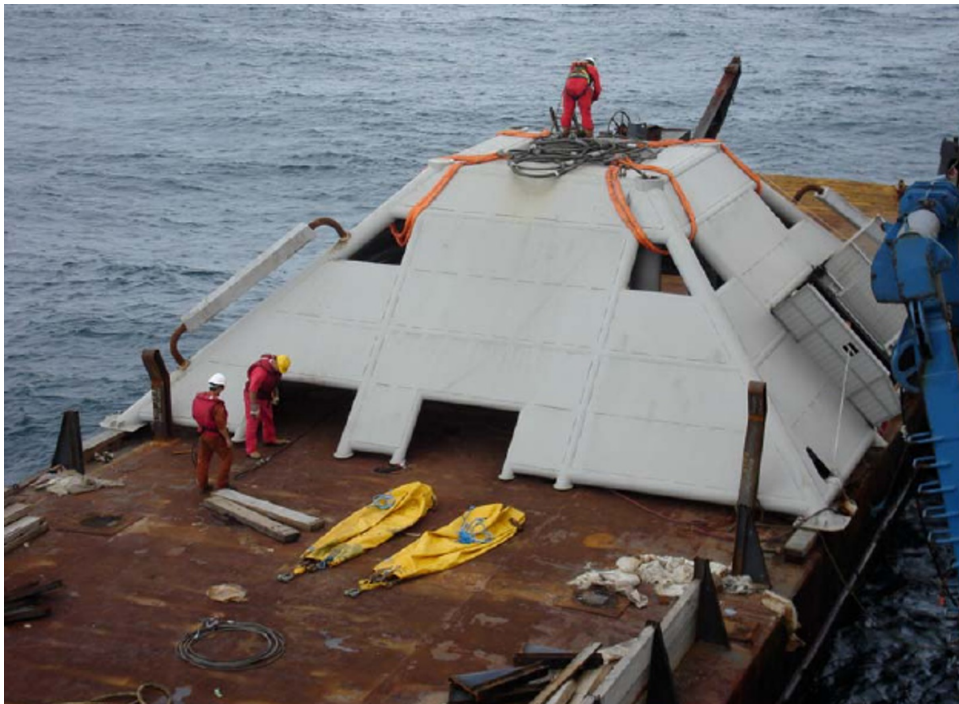
When this large object was deployed over the side of the vessel into the water, the four 15 tonne round slings used in the rigging arrangement parted and the object fell into the seabed. There were no injuries or damage to equipment or seabed infrastructure as, in accordance with the company's procedures, the lift was made over a seabed area free of any field infrastructure.

Investigation revealed that the four round slings obtained from a local supplier had been modified incorrectly and without due authorisation from the original manufacturer.

- Close examination of the slings revealed that the fibre had been cut and re-spliced using numerous knots, hidden under the protective fabric (this could not have been spotted without dismantling the sling)
- Whereas 6 metre (working length) slings had been procured from the local supplier, the manufacturer advised that the serial number on the round slings actually corresponded to 12 metre (working length) round slings. The

manufacturer also advised that it did not fabricate 6 m (working length) round slings of 15 tonne SWL

- There was no manufacturer certificate for the slings available from the supplier
- The blue label showing SWL was stitched to the sling, when it normally should slide around it.

- Rigging equipment shall in future only be procured from approved and recognised suppliers
- Rigging materials are to be always subject to testing and inspection as required by the applicable international standards and company rules
- Exceptions to the above should be subject to a rigorous and thoroughly documented management of change process covering all aspects of the rigging operation.
