## Close approach of AHTS vessel to offshore rig

Safety Flash Published on 16 May 2023 Generated on 28 January 2026 IMCA SF 12/23

An AHTS vessel made a close approach to the mooring lines for an offshore rig.

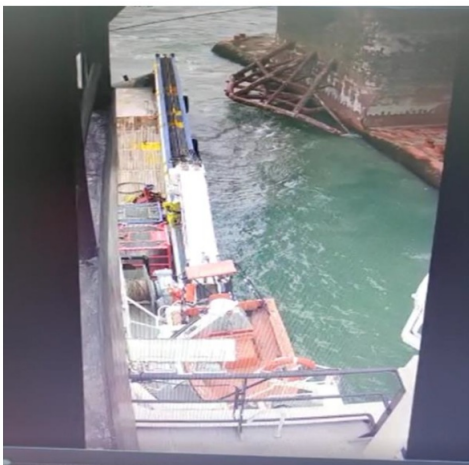
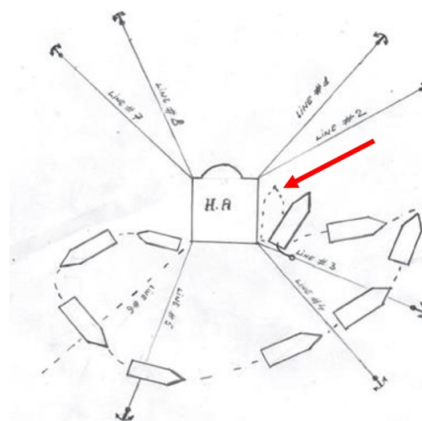
The AHTS was involved in anchor handling operations for the rig. The vessel passed anchor line #6 to the rig and started to move towards anchor line #3.

Control of the vessel was transferred from forward to aft console. Once in position, the vessel received the PCP (Permanent Chasing Pennant) of anchor line #3 by rig crane and it was secured on the Karm fork.

The rig's crane was released, but the chaser's collar slid on the anchor line towards anchor #3 and pulled the stern of the vessel to starboard, resulting in a bow side close approach to mooring line #2.

To stop this movement the Master activated the bow tunnel thruster, but the thruster did not start. As a result, the vessel bow had a close approach to mooring line #2. The Master immediately switched on all thrusters, obtained full manoeuvrability of the vessel, and the vessel pulled away safely.

A line drawing showing the AHTS vessel's movement from anchor line #6 to anchor line #3

- Further review identified that the bow thruster electromotor was off. Machinery required for safe manoeuvring of the vessel had been disabled. The electromotors for the tunnel thrusters had been switched off by the chief officer to rest the machinery as the vessel was leaving the 500m zone. This fact had not been communicated to the Master.

- The fact that the servo pumps were running gave a false assurance of full operability of the thrusters.
- There was no check of full operability after transfer of vessel control from forward to aft control stations.

- Ensured that critical vessel equipment is not switched off or its operational mode changed without the approval of the person in charge on the bridge.
- Manual transfer of vessel control to be followed by mandatory thorough checks of all propulsion relevant to the operation.
- Developed comprehensive work instructions for bridge transfer control.
