Lost time injury (LTI): Trip incident during routine task

Safety Flash Published on 7 August 2014 Generated on 16 January 2025 IMCA SF 14/14

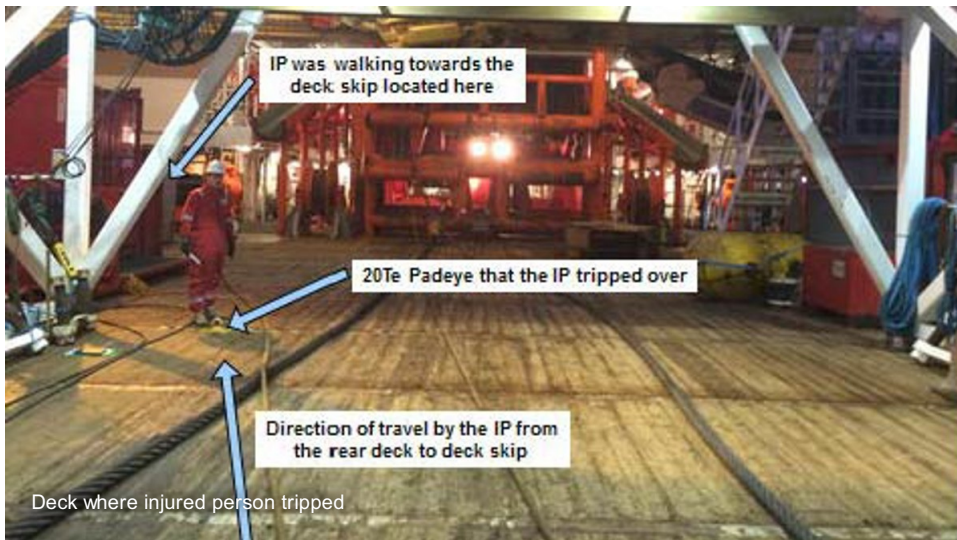
The incident occurred during work on the rear skid of the backfill plough on the starboard side of the vessel. The injured person required something to kneel on. He proceeded to walk forward on the deck from the aft of the vessel towards the deck skip. He then tripped over a 20Te pad eye, lost his balance and fell over, landing on his right shoulder and arm. The injured person was taken to the vessel hospital; the vessel returned to port to allow the injured person to be transferred to a shore-side hospital for further treatment.

- It has been identified that the pad eye was not actually required until the next interim mobilisation, and hence the incident could have been prevented.
- Inadequate planning/risk assessment – without a cordon or other appropriate barriers/markers, this hazard presented an obvious risk, which was not specifically identified. Failure to adequately identify all hazards can result in accidents.
- Inadequate safety controls/warning signs.
- Lack of awareness/perception of risk.

- Lack of attention/due care/poor work practice.

- In this instance there was a lapse of attention while doing something completely 'routine' which had been done many times before, except that this time, the lapse had consequences.
- The key lesson is that we can never be complacent; otherwise, the ever present hazards on our worksites will catch us out.
- It is important that we all take personal responsibility for our own safety and ensure that we do not put ourselves or others 'in the line of fire'.
- Active supervision and intervention must be at the forefront of our daily activities.
- It is essential that everyone:
 - Remains pro-active and maintains a clear focus on hazard identification and accident prevention
 - Uses their own ability to be aware of the situation round about them and look where we place our feet and where we put our hands
- The importance of focus on 'routine' work' – where many incidents are occurring.
