Equipment fell on someone's leg causing injury

Safety Flash Published on 16 July 2024 Generated on 18 February 2026 IMCA SF 14/24

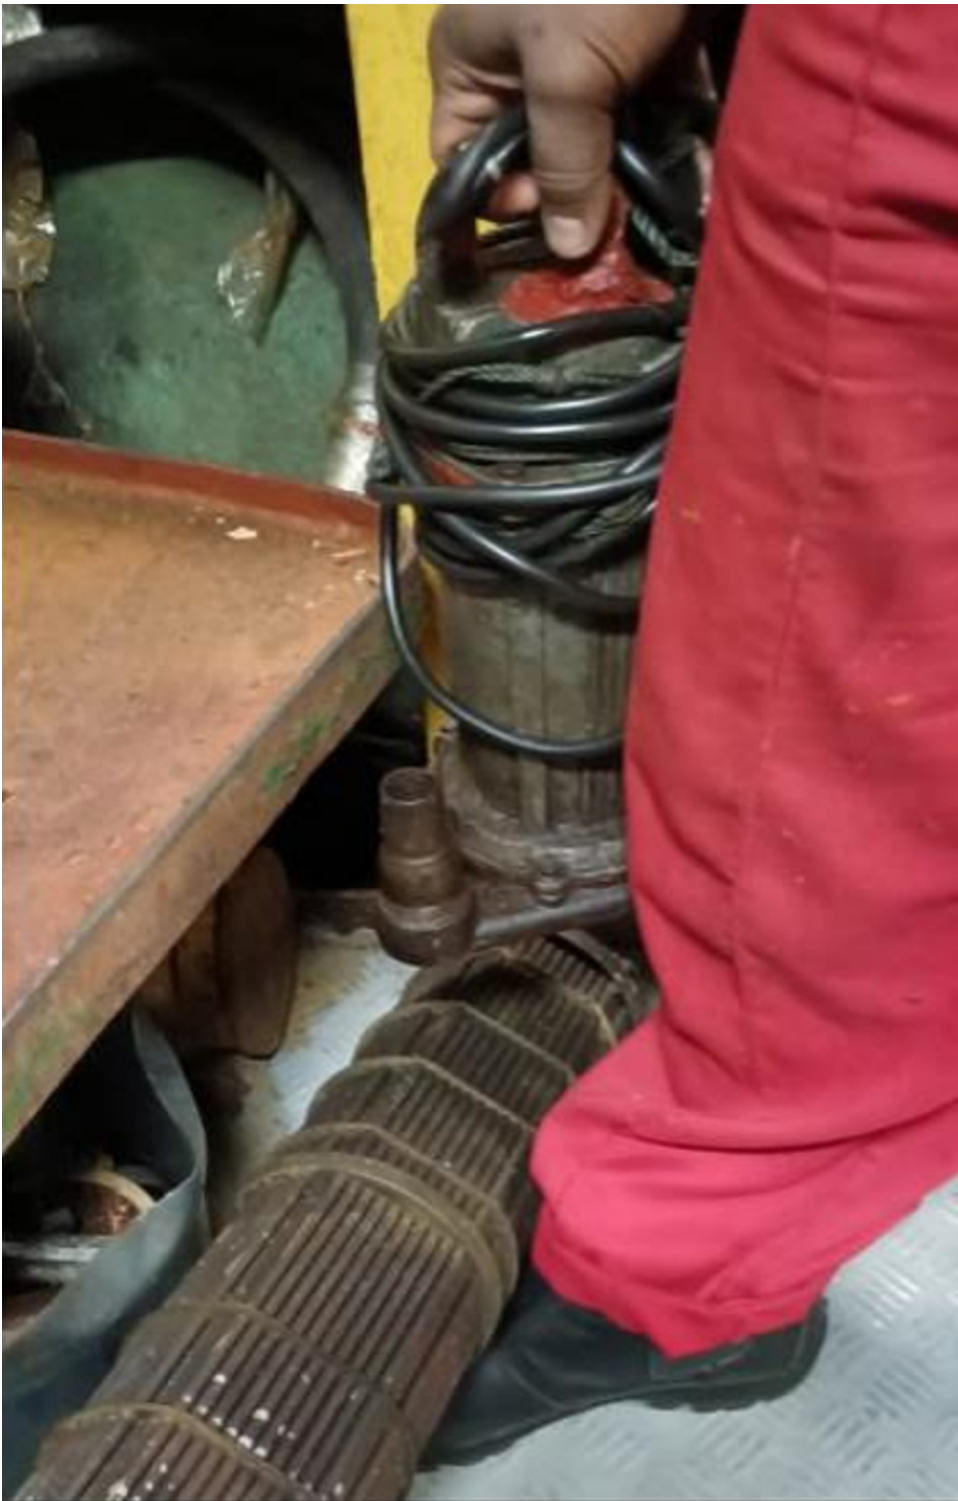
The person was cleaning the bow thruster room which was also used to store parts. He intended to move a portable submersible pump, but another piece of equipment (an auxiliary engine cooler) located near the pump, shifted and fell against his right leg, causing a minor injury.

- The bow thruster room was being used as a storage area.
- The auxiliary engine cooler was neither secured nor lashed down.
- The auxiliary engine cooler was used; it was surplus to requirements and it ought not have even been on board.
- The injury was not reported in a timely way.

- Any loose parts should be well secured.
- Have a thorough inventory: if “spare” parts cannot be used anymore or are beyond repair, send them ashore. Don't keep useless material on board.
- Report incidents immediately; treat all injuries seriously and immediately.
 - This incident should have been reported when it first happened rather than three days later, by which time the injury had got worse.
- Further training of all crew was suggested, to raise awareness of the importance of reporting incidents or near misses as soon as they occur.
