High potential near-miss: Mooring rope parted

Safety Flash Published on 15 June 2017 Generated on 24 January 2025 IMCA SF 15/17

Mooring buoy rope parted while a vessel was moored.

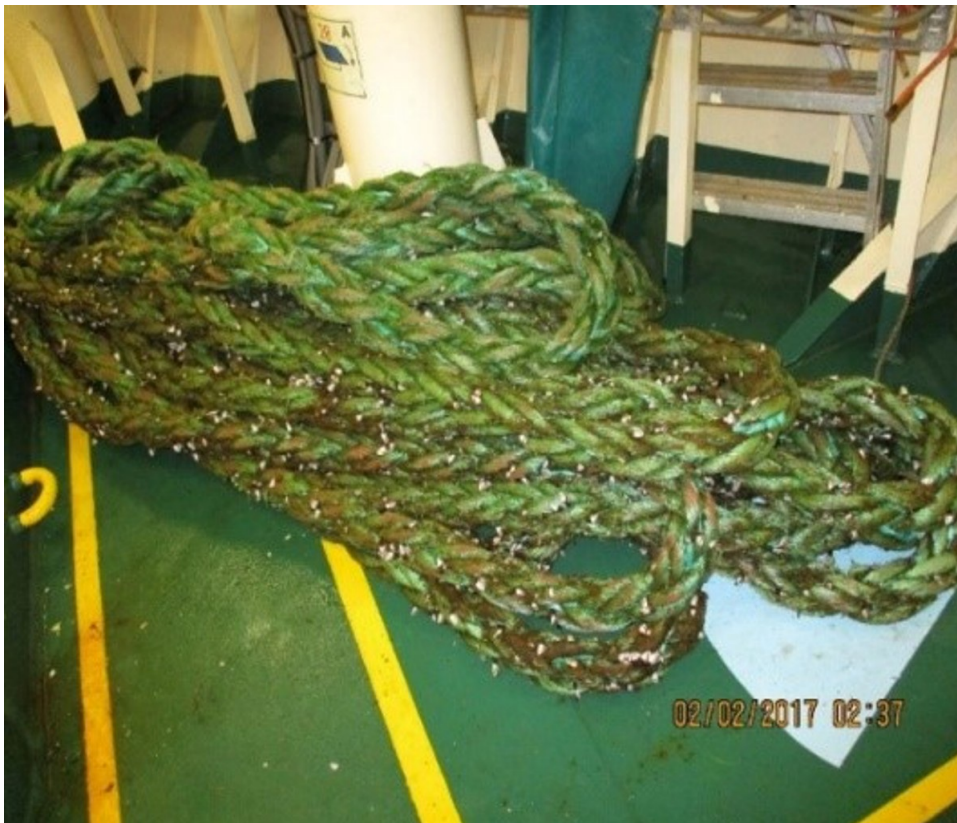
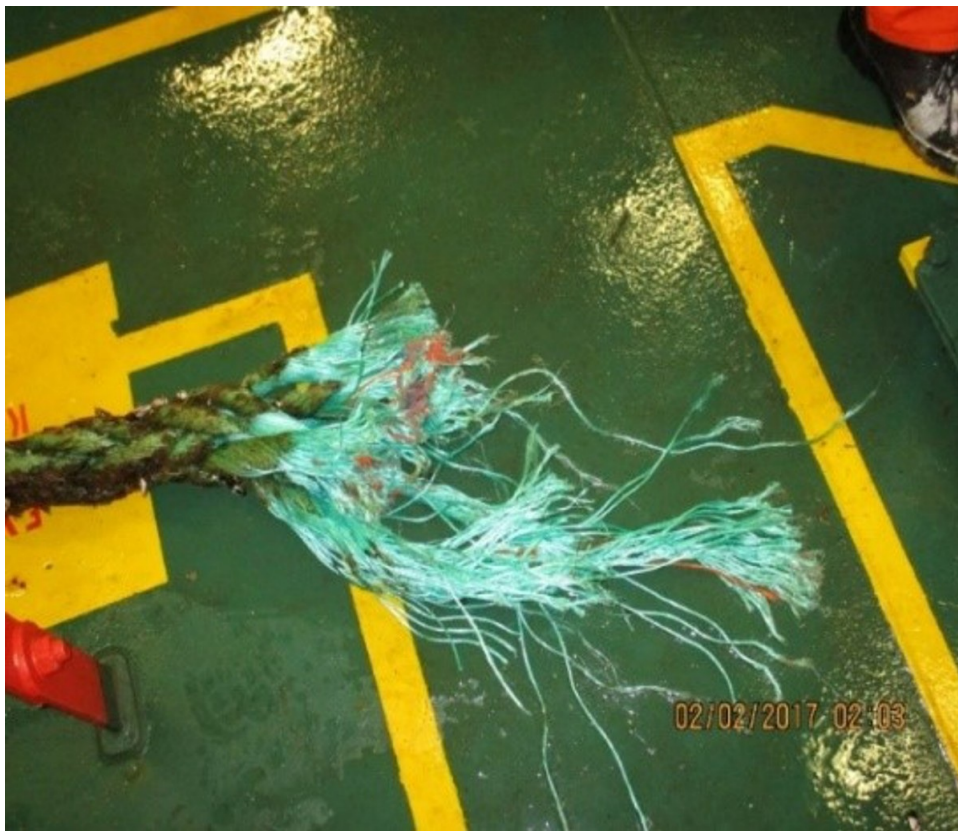
Equipment failure following from wear & tear, in turn following from inadequate or insufficient routine inspection.

It was evident from inspection after the fact that the condition of the mooring rope was bad.

- Planned and regular inspection of mooring ropes.
- If mooring ropes are found in poor condition, they should be taken out of use.
- All crew associated with mooring operations should be properly informed and fully briefed with regard to:
 - the mooring operation in general
 - checking for defects with the ropes
 - proper precautions relating to keeping out of the snap back zone.
